**Arborist Report
for
Garbarino Property
Parcels 1246700321 and 1246700329
Redmond, WA**

**November 12, 2015
Updated 2-8-16
Updated 7-31-18**

American Forest Management was contacted by Greg Arms of Milestone NW and was asked to compile an 'Arborist Report' for a subdivision project involving two parcels in the City of Redmond. The parcel numbers are 1246700321 and 1246700329.

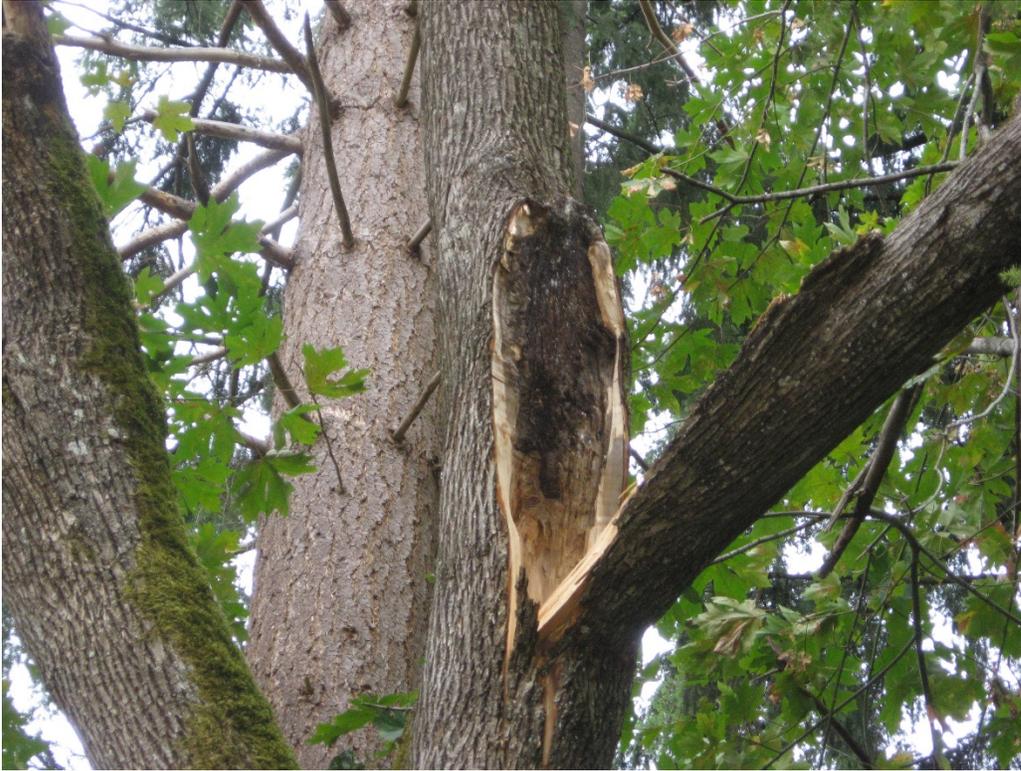
The big leaf maples on the property vary in condition and viability. Several recently suffered major branch and stem failures during the August 29th windstorm. A few have significant infections of *Kretzschmaria deusta*, a soft rot fungus. Many are in decline evidenced by significant dieback of upper crown components and thinning foliage (sparse crowns).

Recent co-dominant stem failure on big leaf maple

Some of the retained subject big leaf maple trees on the north and south perimeters may require corrective pruning and clearance pruning to maintain risks at acceptable levels. This should be evaluated once interior trees that are proposed for removal are cleared from the site.

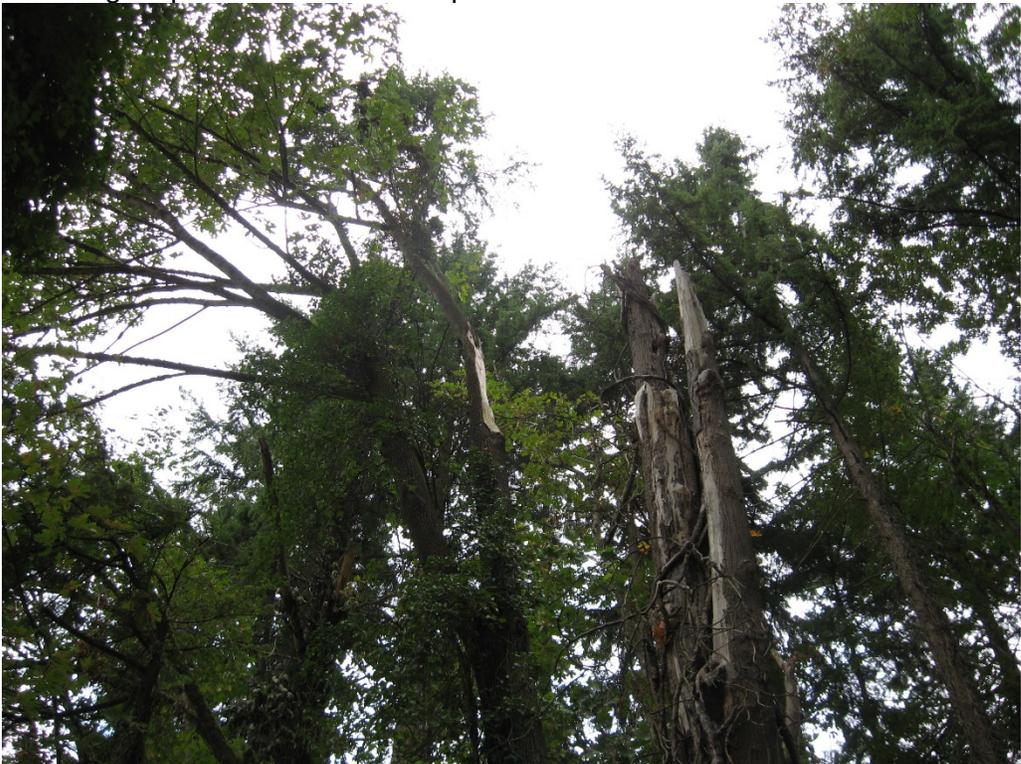
Declining maples – broken/dead tops

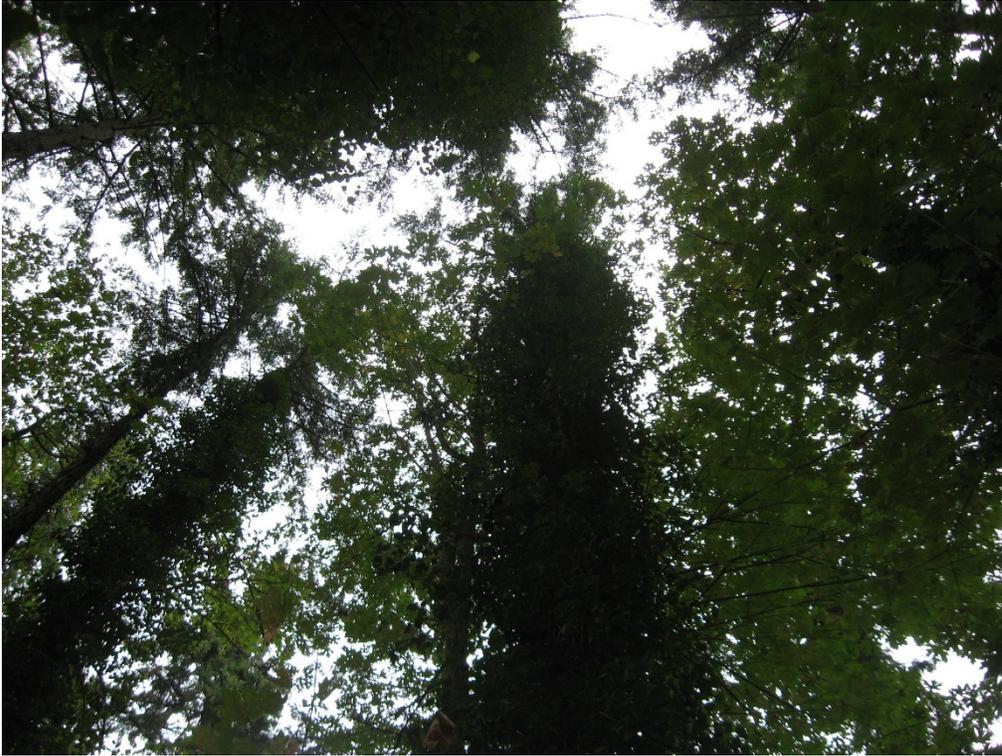
Major ivy problem on south side

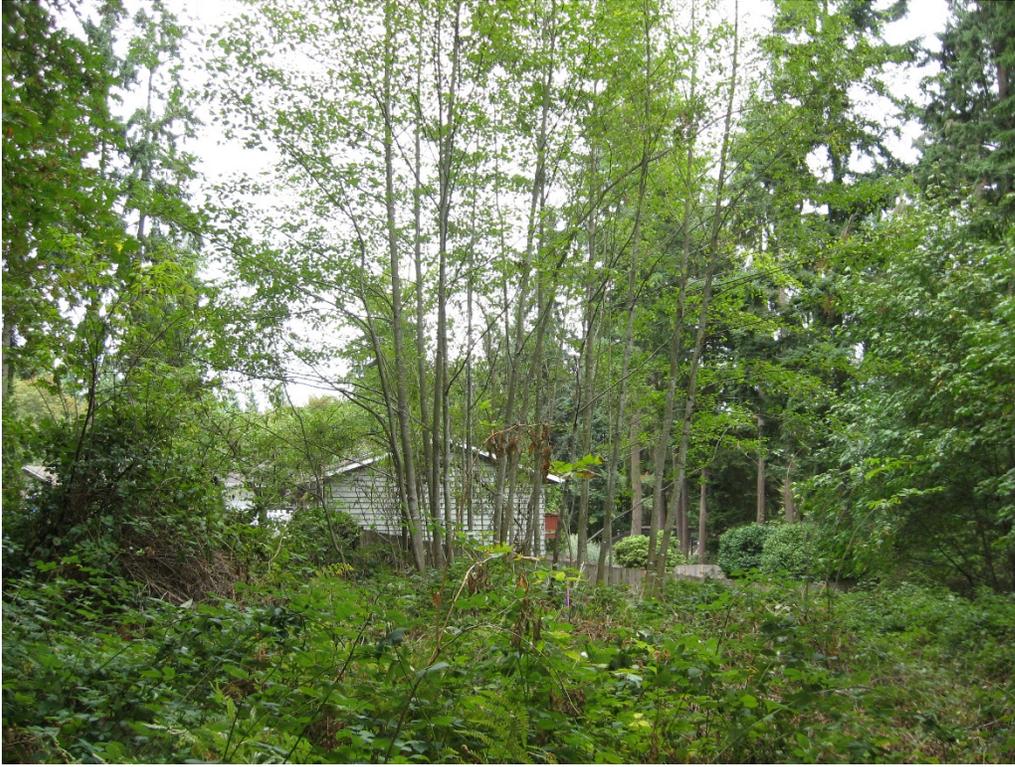
Previously cleared area on east side of property – non-significant alder
