AMERICAN FOREST
MANAGEMENT

**Arborist Report
for
G.W. Williams Co.
7440 159th Pl. NE. Redmond, WA**

**March 4, 2019
UPDATED March 18, 2020**

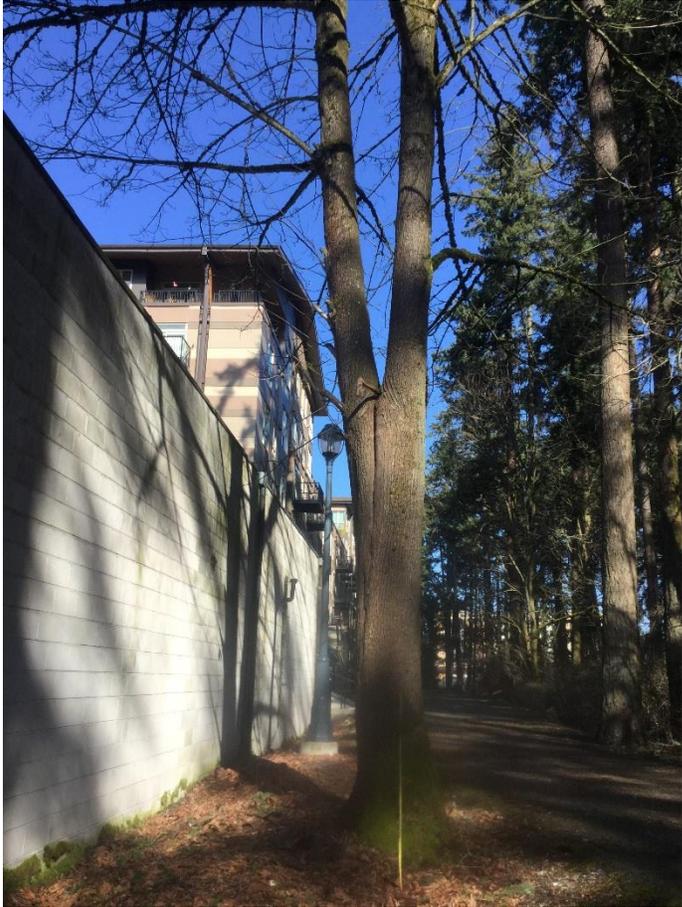
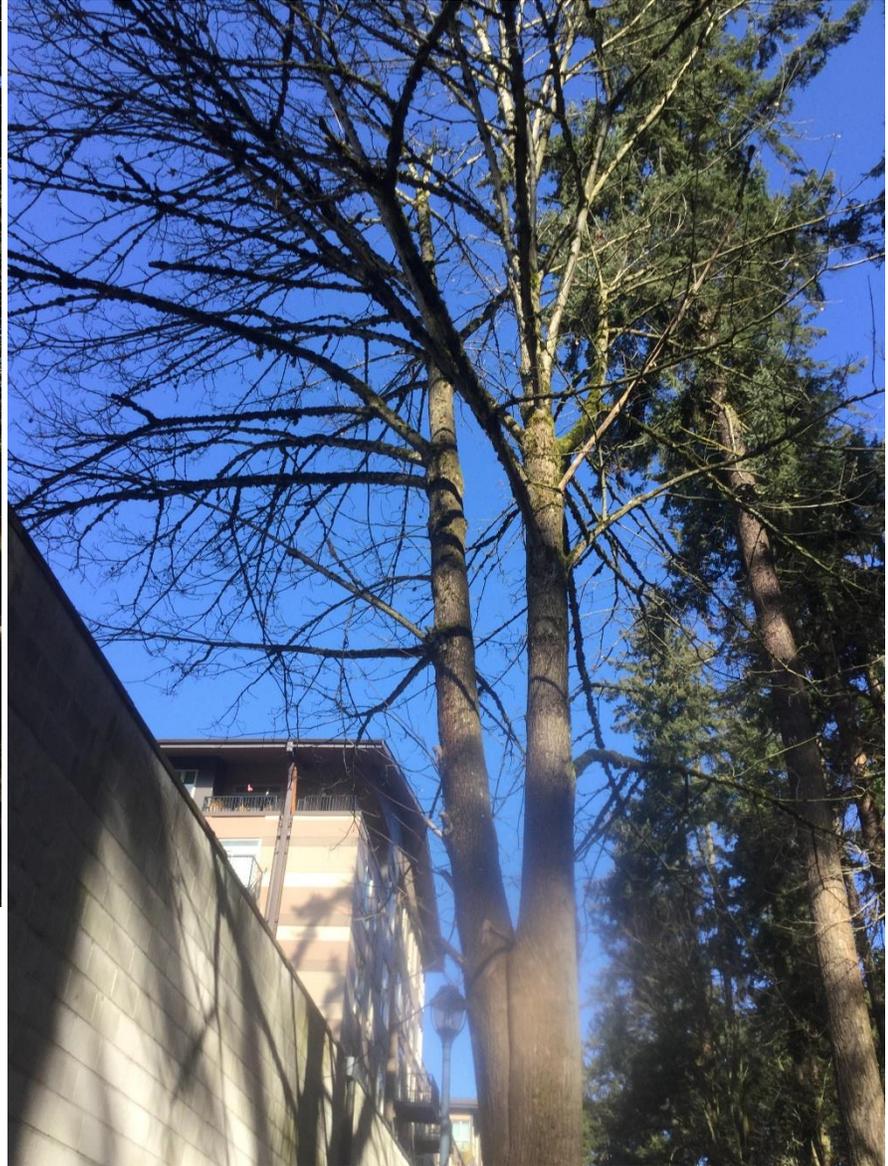
Tree #101 is a fair condition big leaf maple (*Acer macrophyllum*) with a DBH of 23 inches. Its canopy is composed of two primary codominant stems which have not fully fused and create a large zone of included bark. This condition indicates the tree is more prone to large stem failure. The existing structure is 9 feet west of its trunk.

Big Leaf Maple #101, just east of the existing structure on the subject property. Note codominant leaders and included bark.

Tree #101 is 9 feet, and #102 is 11 feet east of the existing structure. There may be significant roots extending from these trees below the concrete foundation and slab. Careful removal of the existing concrete without damaging the roots below is recommended to minimize damage to these trees. Tree protection fencing should be erected as shown on the attached tree locator map. No mechanical tilling of the existing grade should take place within these tree’s CRZ during final landscape installation.

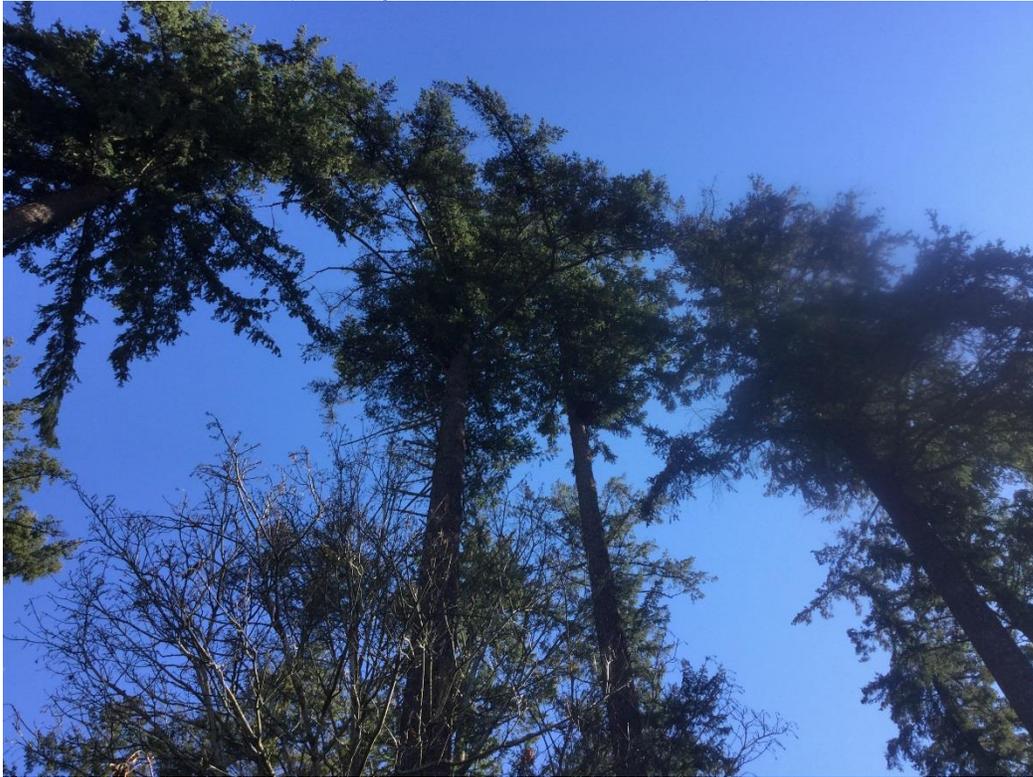
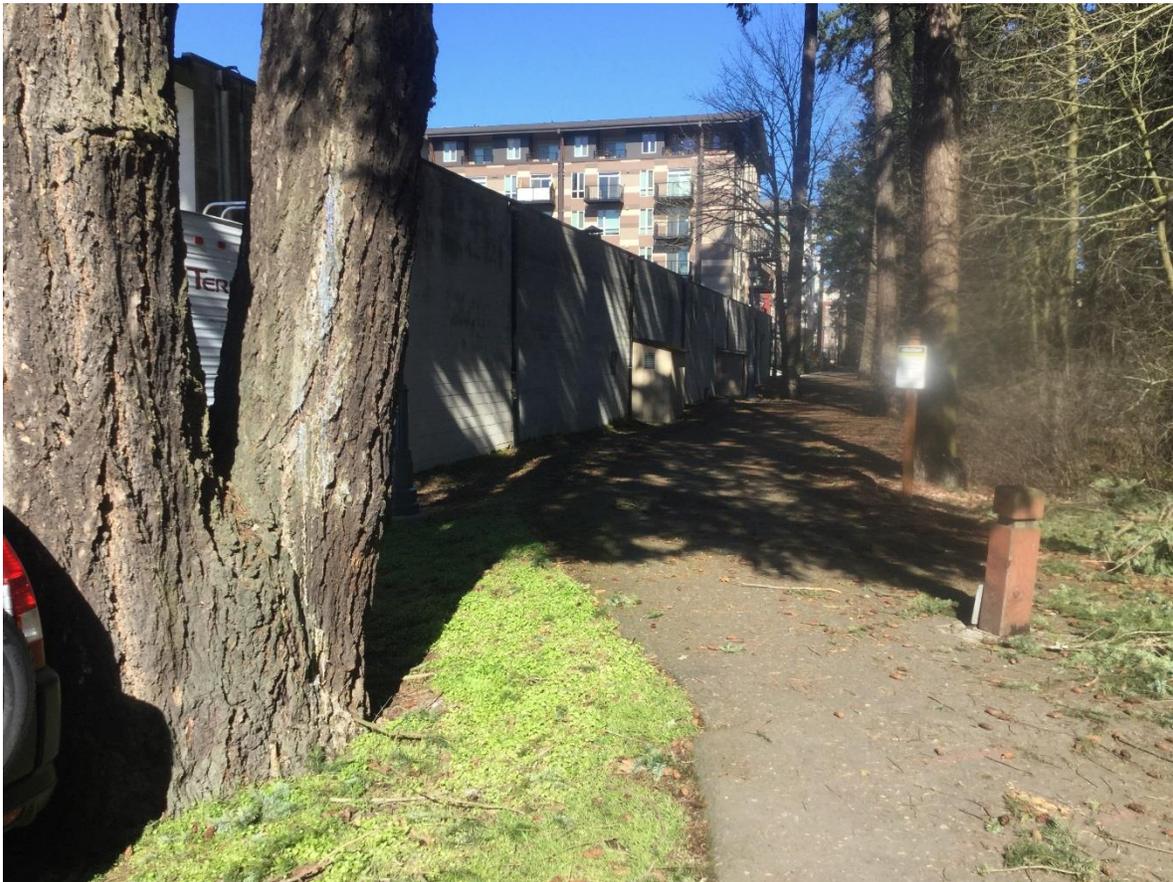
Tree #103 is a 123 foot tall Douglas fir in good condition with codominant stems of 31 inches and 34 inches joined below 4.5 feet for an average DBH of 32.5 inches earning it 'Landmark' status.

Douglas Fir #103. Note codominant stems joined low.

The proposed plan requires an Emergency Vehicle Access lane (EVA) approximately 10.5 feet west of Tree #103. Pavement from the existing parking lot currently extends to 3 feet west of this tree. This pavement will need to be carefully removed to prevent damaging roots found below. The grading and installation of this access lane should be accomplished in a way to minimize excavation or compaction which will lead to loss of roots within the CRZ. Utilizing a Cellular Confinement System (CCS) within the 6 inch CSBC layer shown in the profile view below will minimize compaction to this tree’s CRZ. Further information regarding benefits and installation of CCS are outlined in the attached Site Guidance Note.
