# SHOFFNER CONSULTING

RE: Tree Inventory Report - Wastewater Pump Station No. 12 Replacement - Redmond.

**TREE EVALUATION DATA**

**BHC Consultants - Pump Station 12**

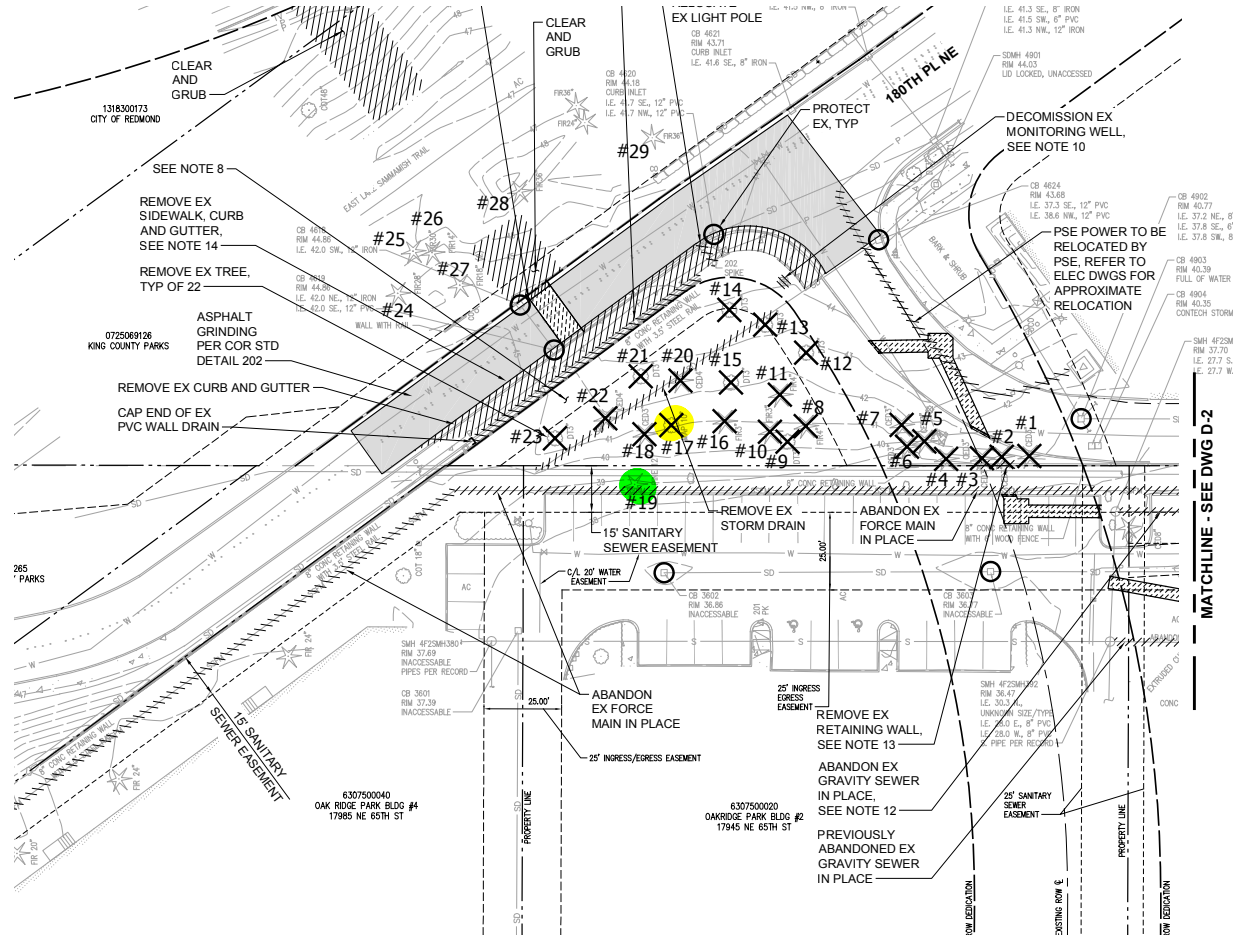
Six trees located off-site to the east classify as impacted as the force main construction for the pumpstation will take place within their drip lines/drip line setbacks. These trees are identified as numbers 24, 25, 26, 27, 28 and 29. All are medium to large Douglas firs in good condition and health.

Given the nature of the impact associated with the work in their vicinity and the considerable distances from the trees, the impacts to these trees will be minor and will have very little effect upon their condition and health. RZC 21.72.060.C.3 requires description of additional measures for tree protection to ensure the long term viability of the tree.
