AMERICAN FOREST
MANAGEMENT

**Brumbaugh and Associates
Microsoft Athletic Fields
Redmond, WA**

Arborist Report

May 9, 2018

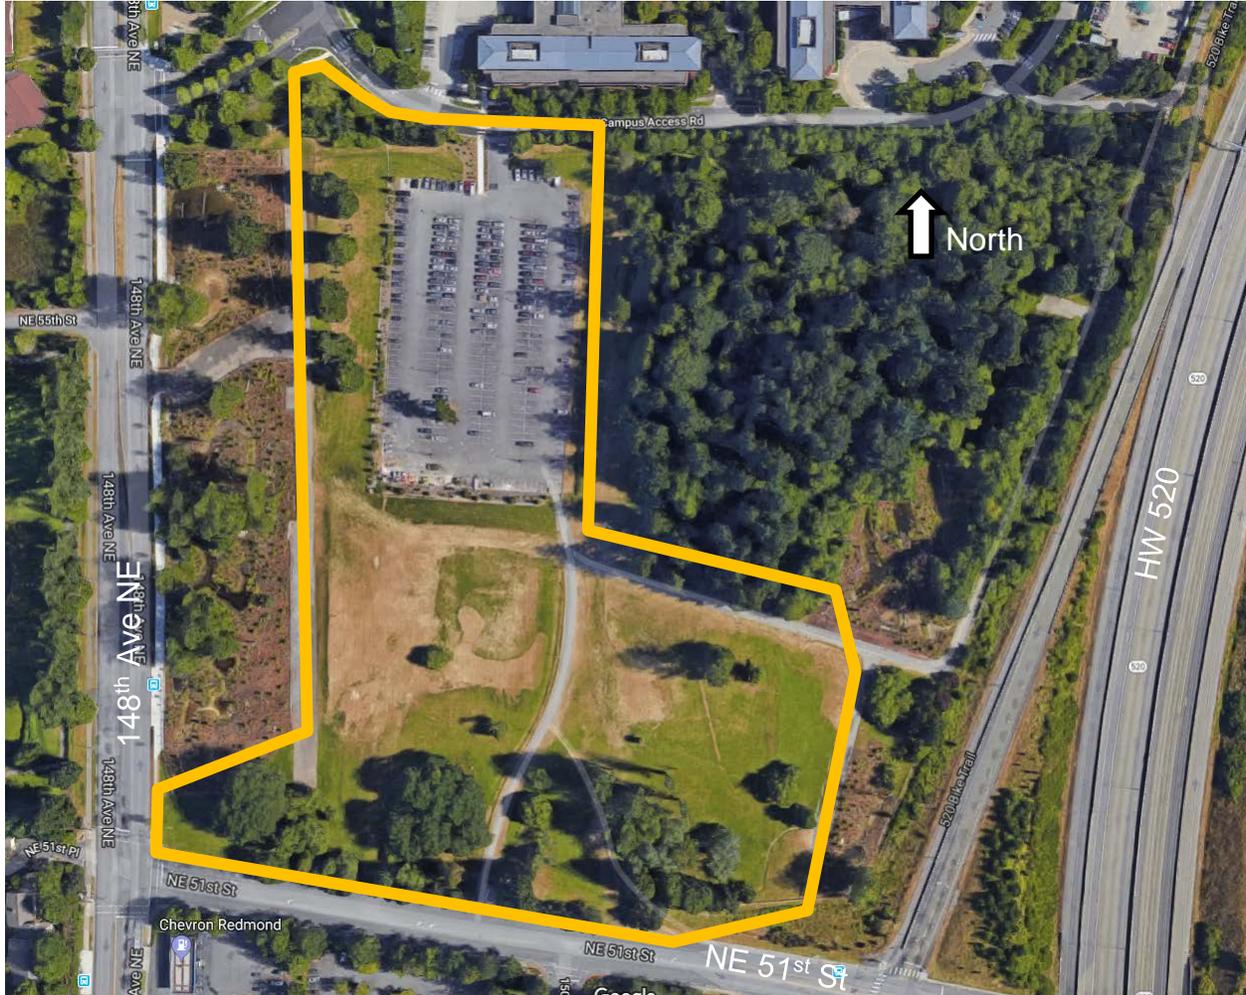
Site

Area surveyed outlined in orange.
