- Tree Protection Plan -

BETROZOFF SITE

11818, 11845 Woodinville-Redmond Road
Redmond, WA

Date: September 19, 2013

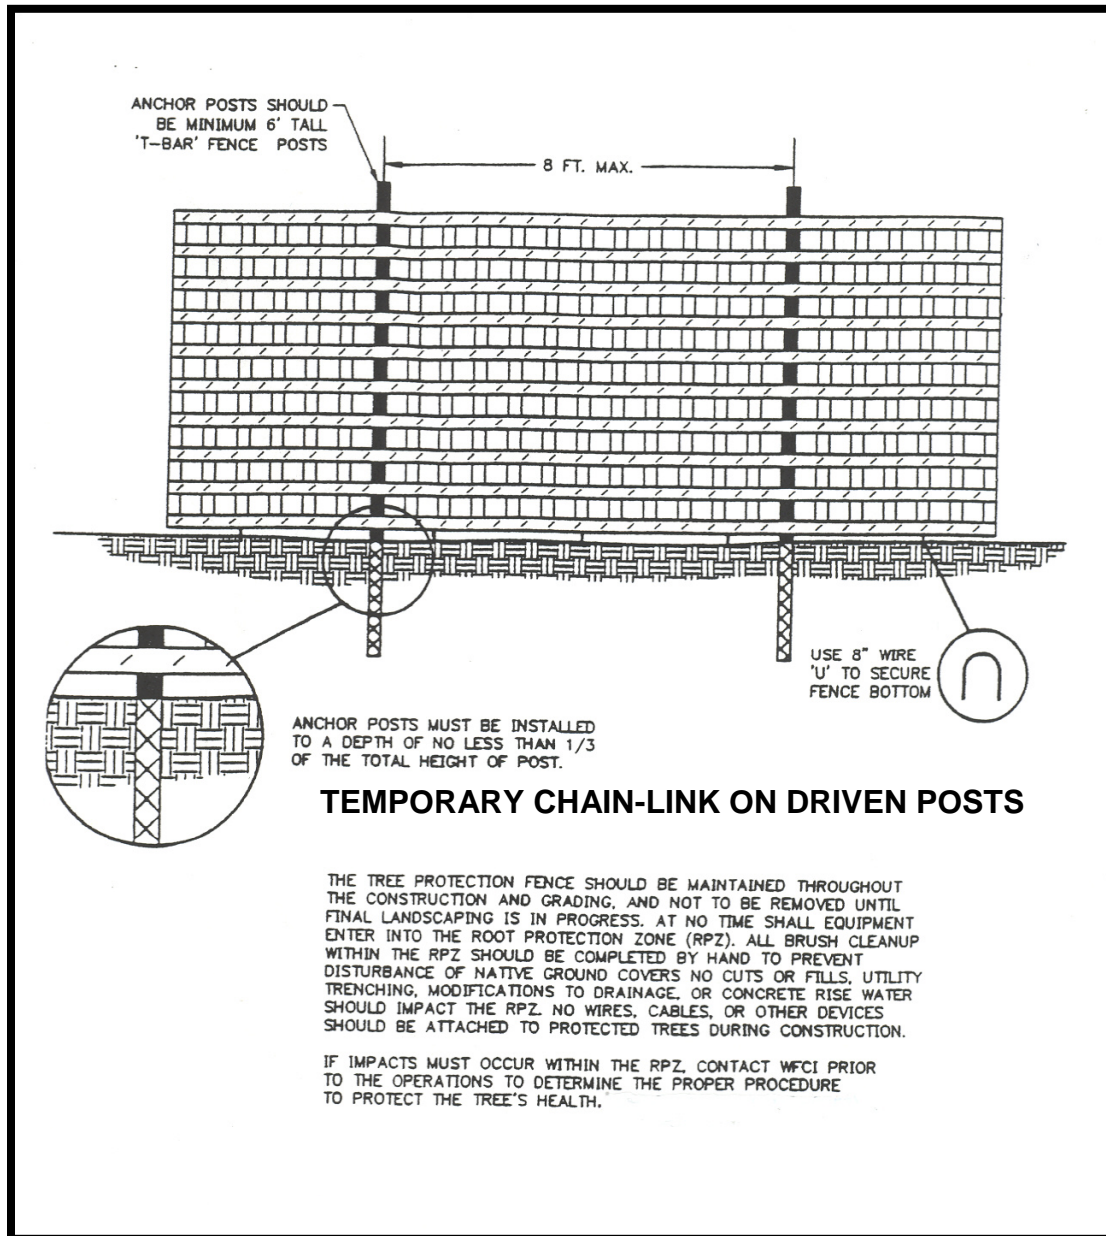
APPENDIX IV

Tree Protection Fence Detail

Trees to be saved must be protected during construction by temporary chain-link or plastic fencing on driven posts, located at the edge of the critical root zone. The individual critical root zones are a radius of 1' for each 1" of DBH (6' minimum), unless otherwise delineated by WFCI.
