- Tree Protection Plan -

## **BETROZOFF SITE**

11818, 11845 Woodinville-Redmond Road  
Redmond, WA

Date: September 19, 2013

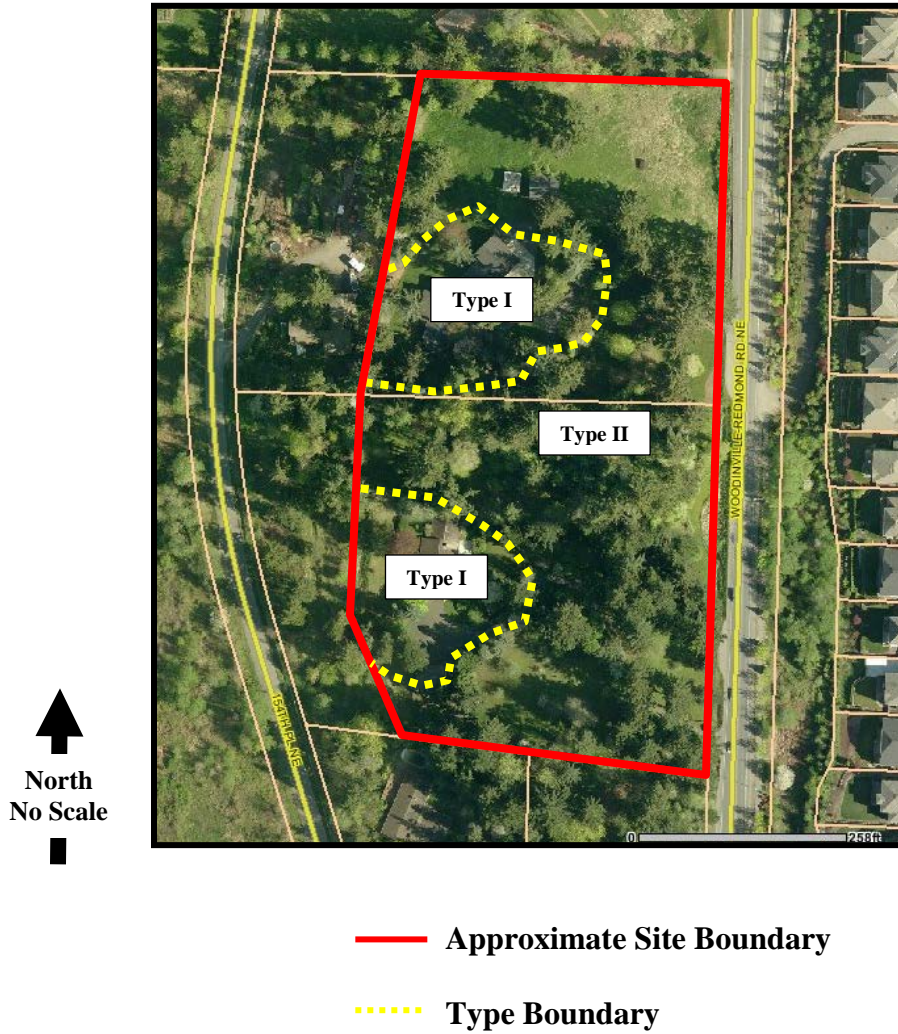
### Forest Cover Types Aerial Photo of Betrozoff Jones Site (King County 2009 iMap)

For the purposes of description, there are two forest cover types on the site (Appendix I).

Type I. -- This type includes the areas around the house that contains both native and planted trees in the landscape. The trees range in diameter from 6 to 34 inches diameter at breast height (DBH).

Type II. -- This type includes the remaining native vegetation on the site. The trees range in diameter from 6 to 49 inches diameter at breast height (DBH).

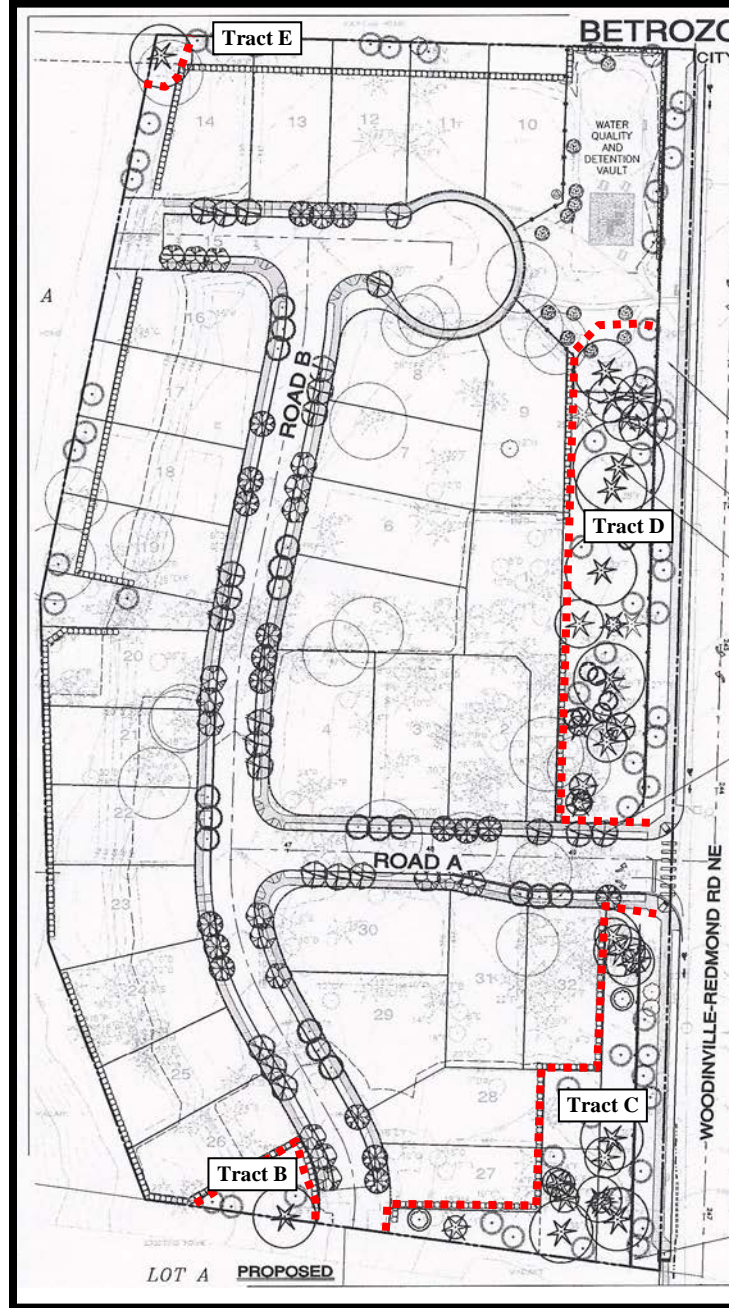
### Site Plan of Betrozoff Jones, LLC Project - Tree Protection Plan Map

Illustrates Tree Protection Fence Locations

All Trees within Buildable Area are Proposed for Removal

Trees to be saved must be protected during construction by temporary chain-link or plastic fencing on driven posts, located at the edge of the critical root zone. The individual critical root zones are a radius of 1' for each 1" of DBH (6' minimum), unless otherwise delineated by WFCI.
