**TO:** Landmark Commission

**SUBJECT: Certificate of Appropriateness II for Redmond State Bank**

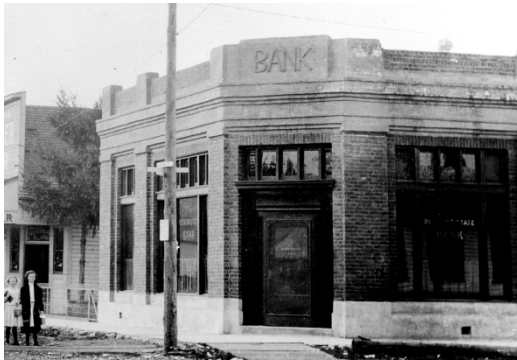
Redmond State Bank is a small one-story, one-part commercial block building, essentially a simple box with entry and fenestration, and simple ornamentation. It is rectangular in plan and has a cutaway corner entrance. The building rests on a poured concrete foundation and base that was exposed prior to a 1981 remodel. The base is now covered with modern red brick that is different in size and finish than the original brick.

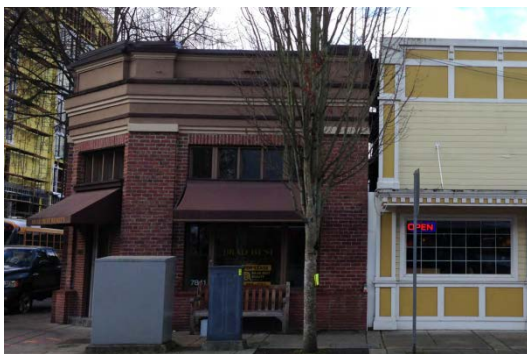
The building has two primary facades, one facing Cleveland Street (south elevation) and the other facing Leary Way (east elevation). The built up flat roof has a stucco-clad parapet on both primary elevations. The south facing facade has two asymmetrical bays separated by simple brick pilasters capped with plain concrete capitals. The east facade has a single bay flanked by identical brick pilasters. The corbelling and concrete trim of the cornice below the parapet are original. The window openings are original and contain large display windows framed in wood with multi-light transoms above. The front door opening has been infilled with a centered aluminum and glass door flanked by the same non-original brick used on the building's base. The building remains largely intact with only minimal changes. It retains integrity of location, materials, setting and design.
