CRITICAL AREA REPORT

**Westside Park
Redmond, Washington**

Title: Critical Area Report for
Westside Park
Redmond, Washington

Project Number: 2019-082-003

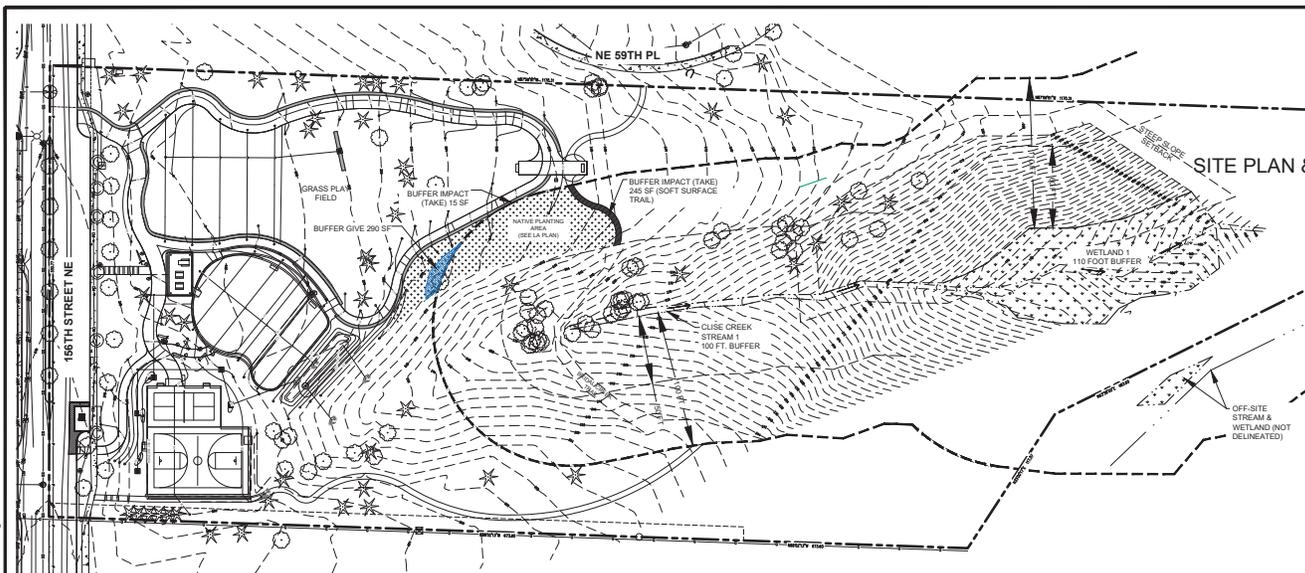
FIGURE 12
 BOARD & VELLUM
 WESTSIDE PARK
 REDMOND, WA
 CRITICAL AREAS REPORT
 SITE PLAN & PROPOSED MITIGATION

- PARK BOUNDARY
- WETLAND
- STREAM
- WETLAND/ STREAM BUFFER
- INNER BUFFER
- BUFFER TAKE- 260 SF
- BUFFER GIVE- 290 SF
- NATIVE PLANTING AREA
SEE LANDSCAPE ARCHITECT PLAN

- As noted above, the total area of proposed buffer encroachment will total 260 square feet. The proposed area of buffer give will be approximately 290 square feet. The proposed area of buffer give will also be enhanced with native trees and shrubs and should provide significantly better quality of habitat than the existing lawn; and

As noted above, the project will result in approximately 260 square feet of impact to the buffer of Stream 1. To compensate for these impacts, approximately 290 square feet of buffer in the northeast portion of the project site will be provided through buffer averaging and will be enhanced with a mixture of native trees and shrubs (see Figure 12). The additional buffer provided through averaging will be contiguous with an area that will be enhanced with native trees and shrubs. The overall project will not result in an adverse impact to the Stream 1 or its buffer. The proposed buffer after averaging should provide a greater degree of habitat form and function after completion of the project.

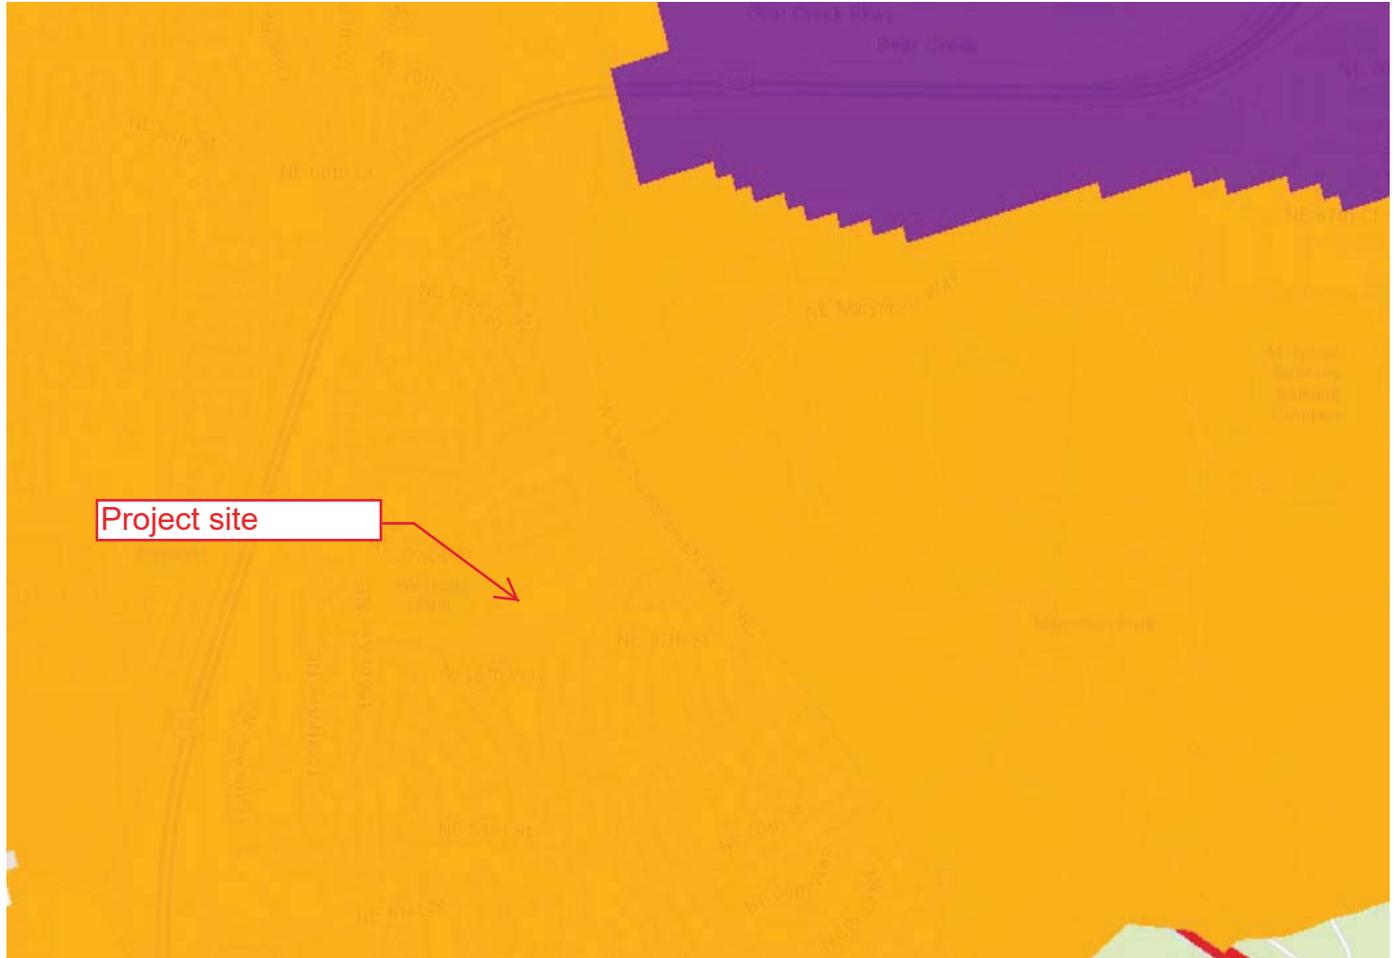
Westside Park Redmond - Wetland 1 Figure 5
 2014 WDOE Rating Questions: R3.3

Date: 11-25-19
RAI Project No, 2019-082
Data Source: WDOE Water Quality Atlas

Project site

WQ Improvement Projects

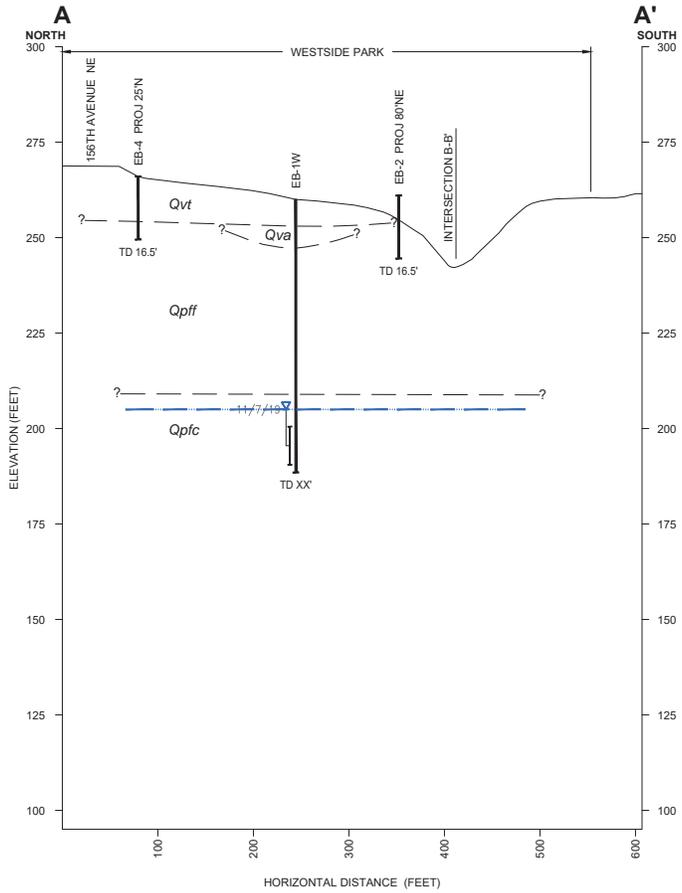
PROJ NO. 20190366H001 DATE: 4/20 FIGURE: 4

- Qvt VASHON LODGEMENT TILL
- Qva VASHON ADVANCE OUTWASH
- Qpf_f PREDOMINATELY FINE GRAINED PRE-FRASER DEPOSITS -
- Qpf_c PREDOMINATELY COARSE GRAINED UNDIFFERENTIATED PRE-FRASER DEPOSITS -

SCHMATIC HYDROGEOLOGIC CROSS-SECTION A - A'
 WESTSIDE PARK
 REDMOND, WASHINGTON
