# FAIRWEATHER DUPLEX CRITICAL AREAS REPORT

**PROJECT:** Fairweather Duplex

## *Critical Aquifer Recharge Area Evaluation*

### **FAIRWEATHER DUPLEX**

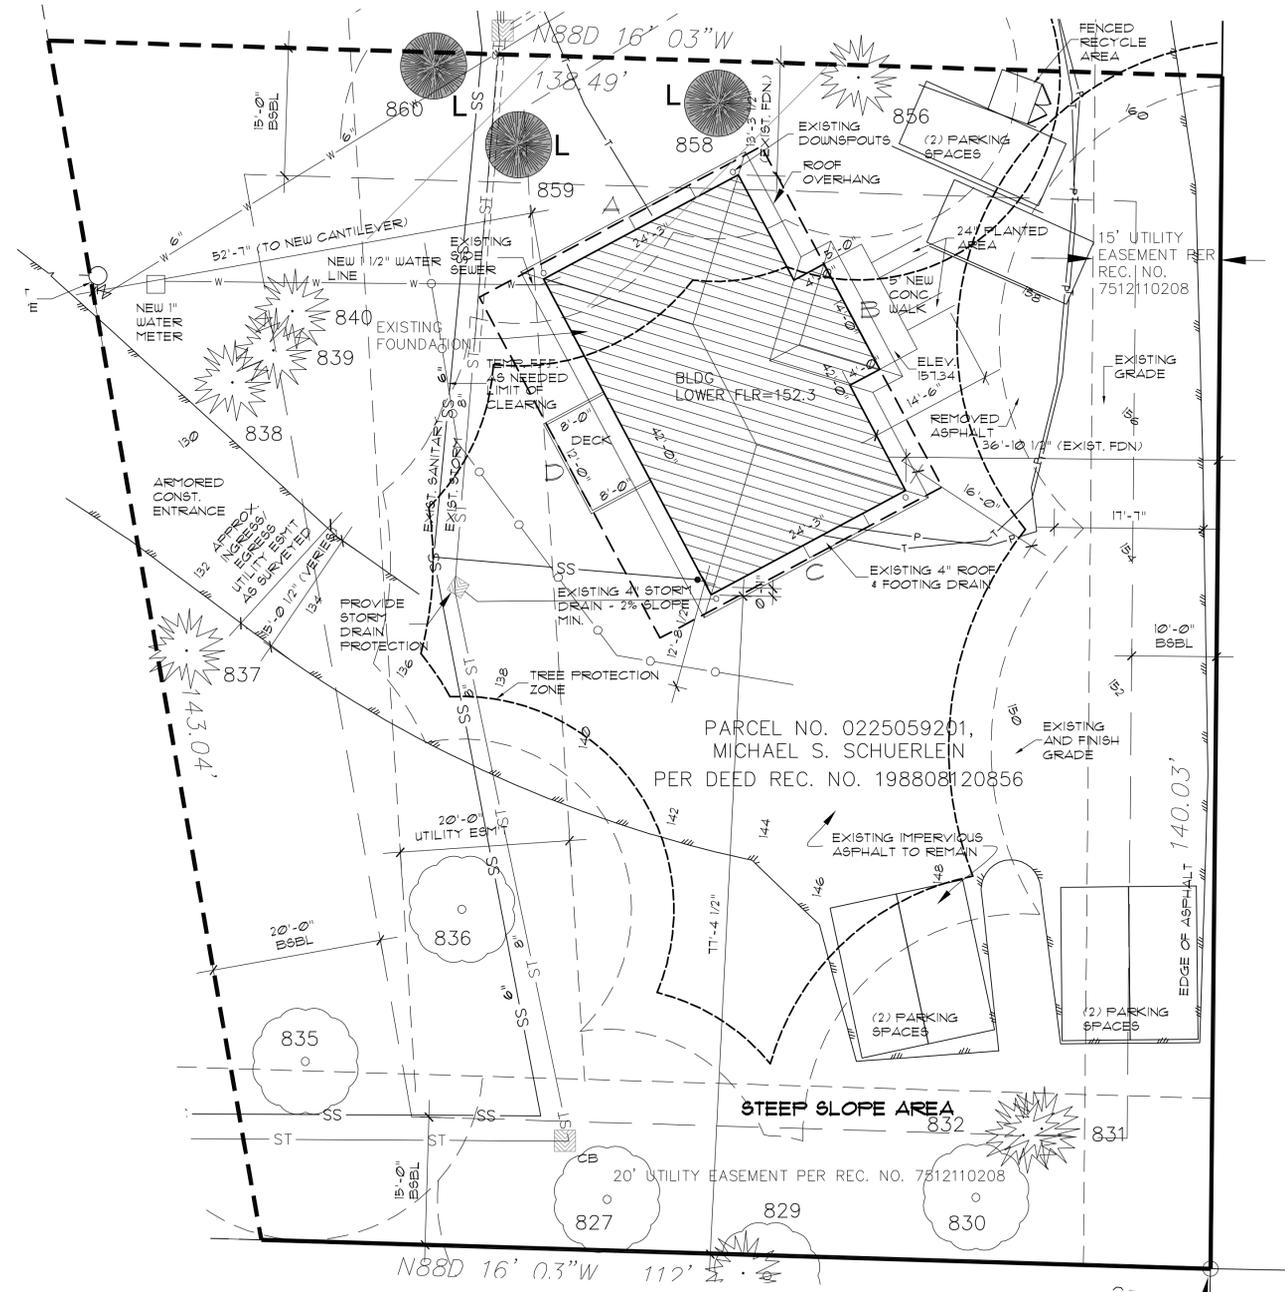
**EXHIBIT 'A'**  
**SITE PLAN**

**GEOLOGICALLY HAZARD AREAS REPORT:** An ALTA Survey conducted in 2014 by D.R. Strong Engineers identified a Steep Slope Area located on the South Property Line. This area has been stable since 1975. A site plan showing the Steep Slope Area is attached as Exhibit A.

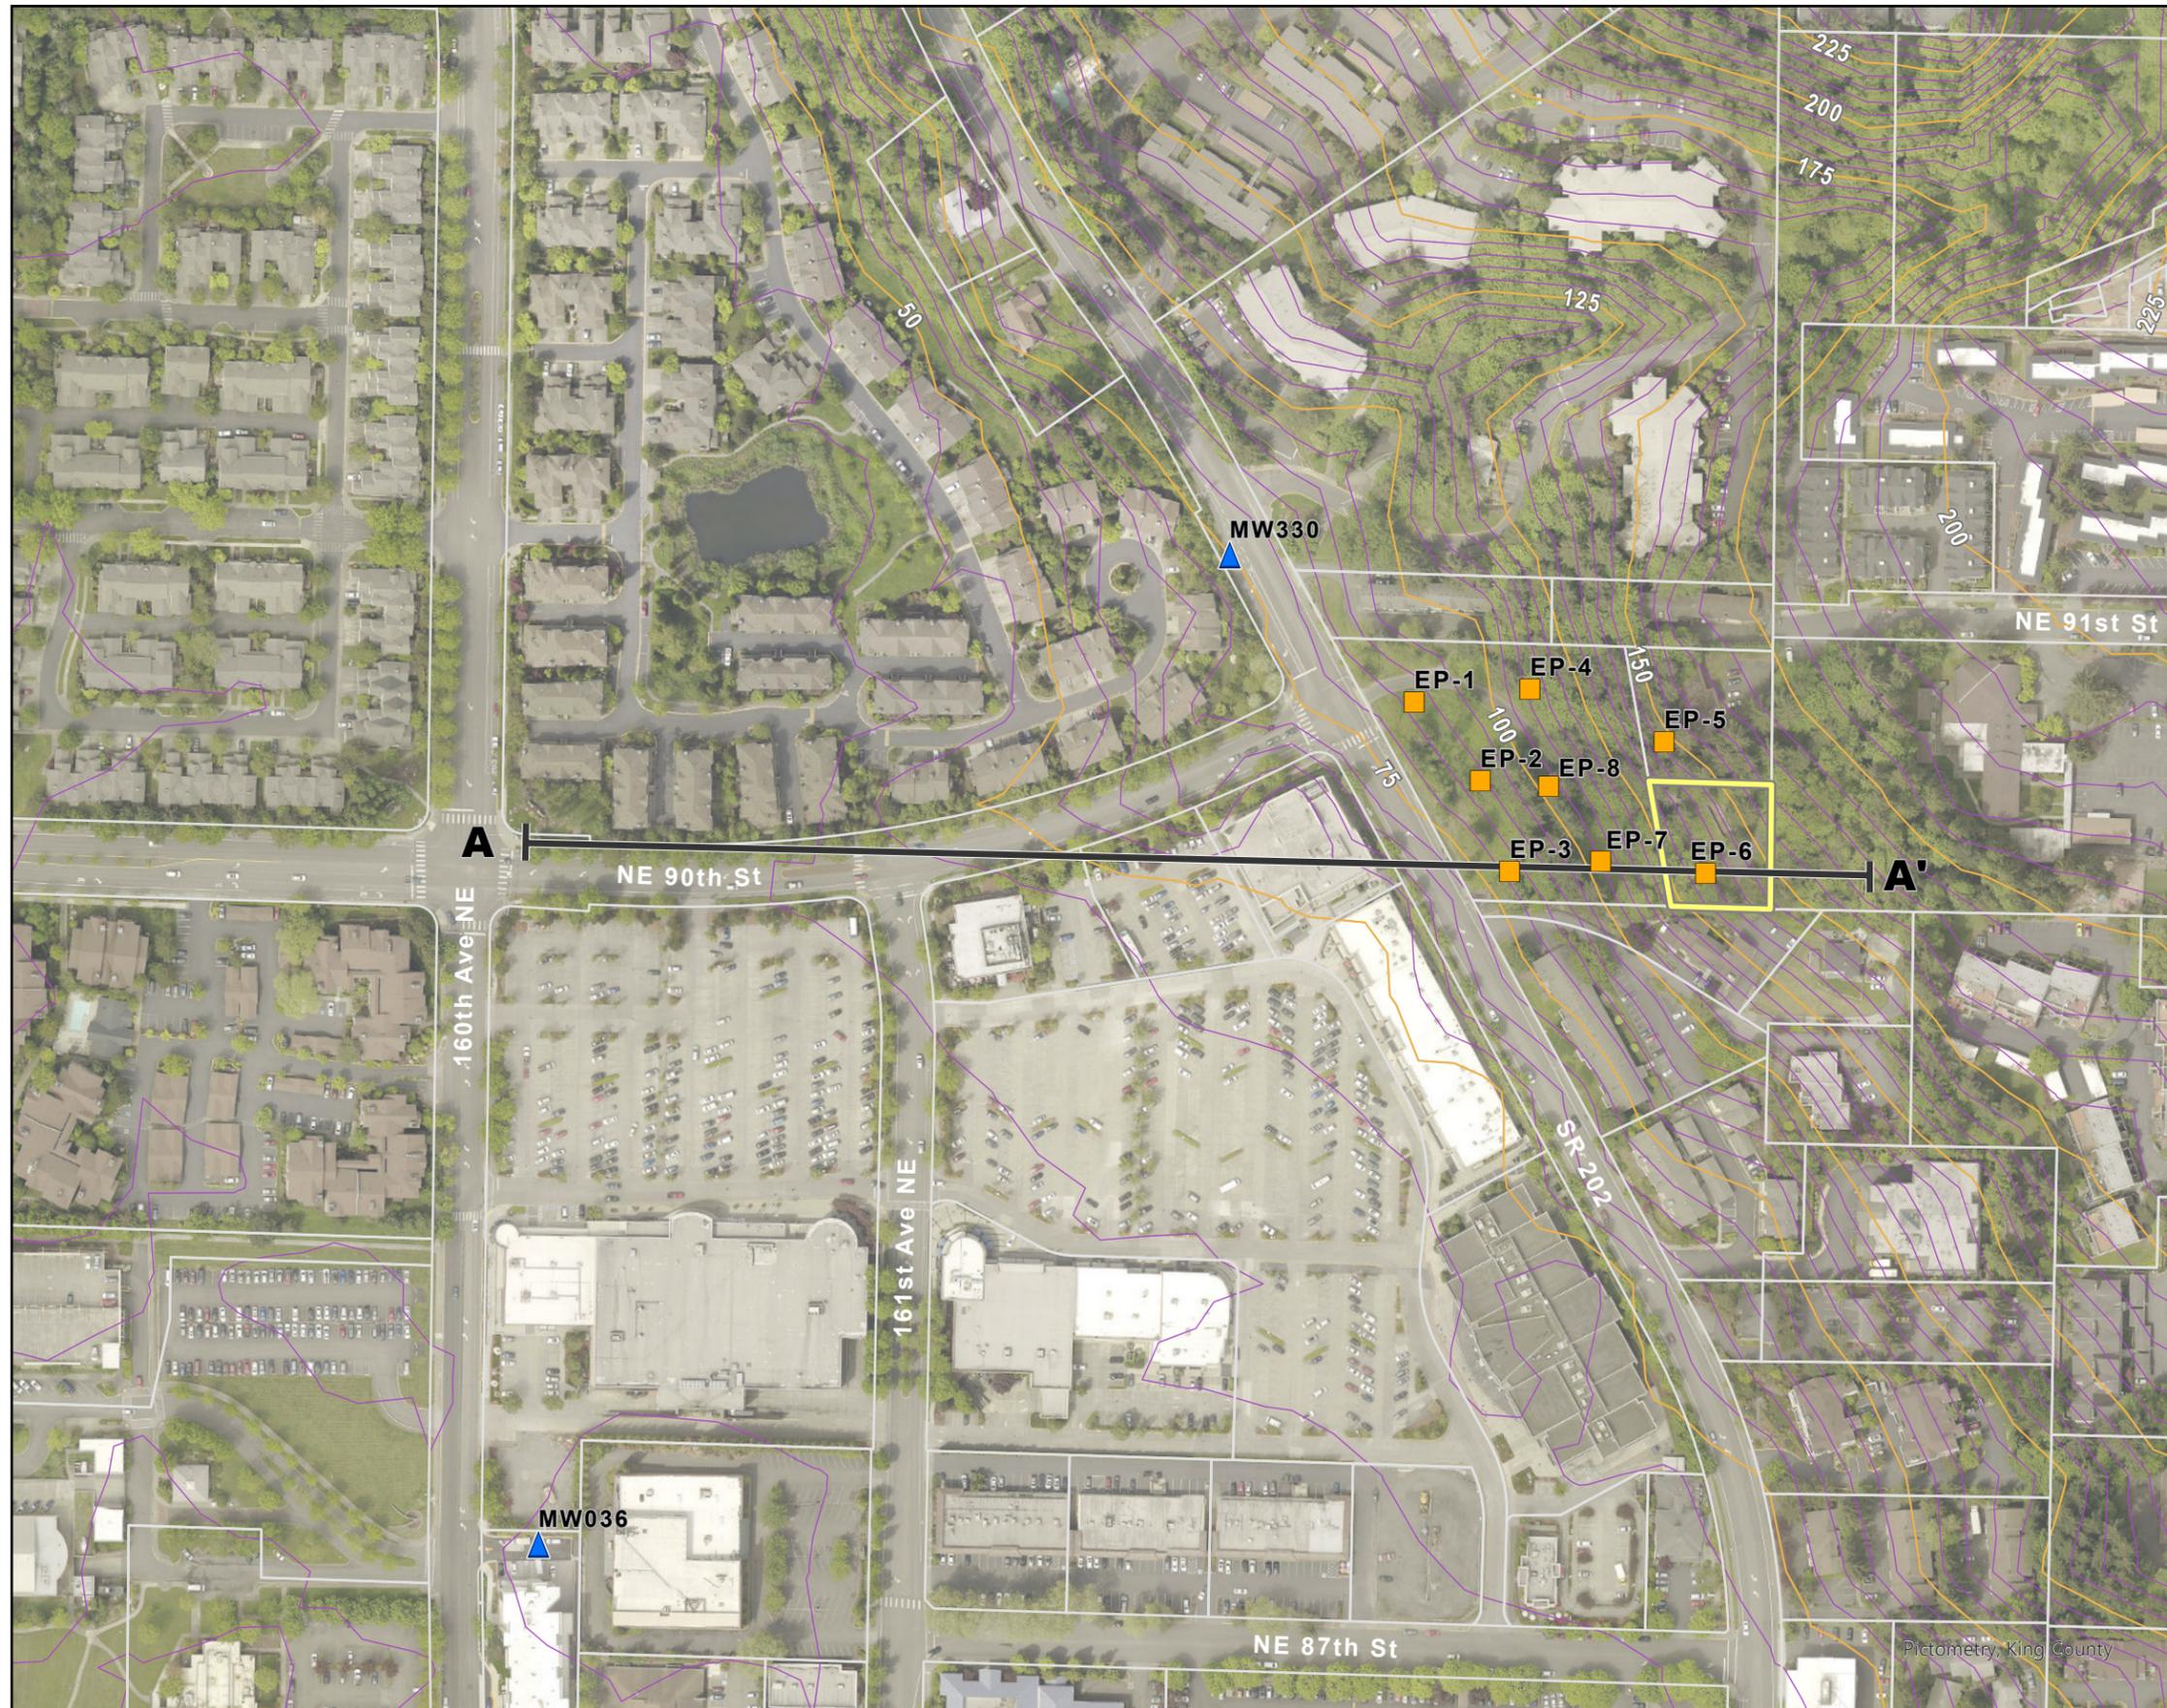
**EXISTING SITE AND EXPLORATION PLAN**  
**FAIRWEATHER DUPLEX**  
**REDMOND, WASHINGTON**

- SITE
- EXPLORATION PIT (1998)
- CITY OF REDMOND MONITORING WELL
- CROSS SECTION
- CONTOUR 25 FT
- CONTOUR 5 FT
- PARCEL

Two of our exploration pits, EP-1 and EP-2, encountered fill soils (those not naturally placed). The fill encountered consisted of loose to medium dense, moist to wet, brown, silty sand with varying amounts of gravel, occasional roots, and scattered wood debris. These soils ranged from 2 to 3½ feet in EP-1 and EP-2, respectively.

The sediment encountered below the surficial fill layer at the locations of exploration pits EP-1 and EP-2 consisted of debris flow deposits. At the location of pit EP-1, the debris flow deposits were approximately 1½ feet in thickness, and consisted of loose to medium dense, silty sand with gravel, some cobbles, scattered boulders, and lumps of silt. At the location of pit EP-2, the debris flow deposits consisted of approximately 4½ feet of medium dense, moist, silty sand with some gravel and scattered cobbles, underlain by a 1½-foot-thick bed of stiff, wet, mottled, blue-gray silty clay. The clay layer exhibited a sheared appearance, and contained moderate amounts of organic debris.

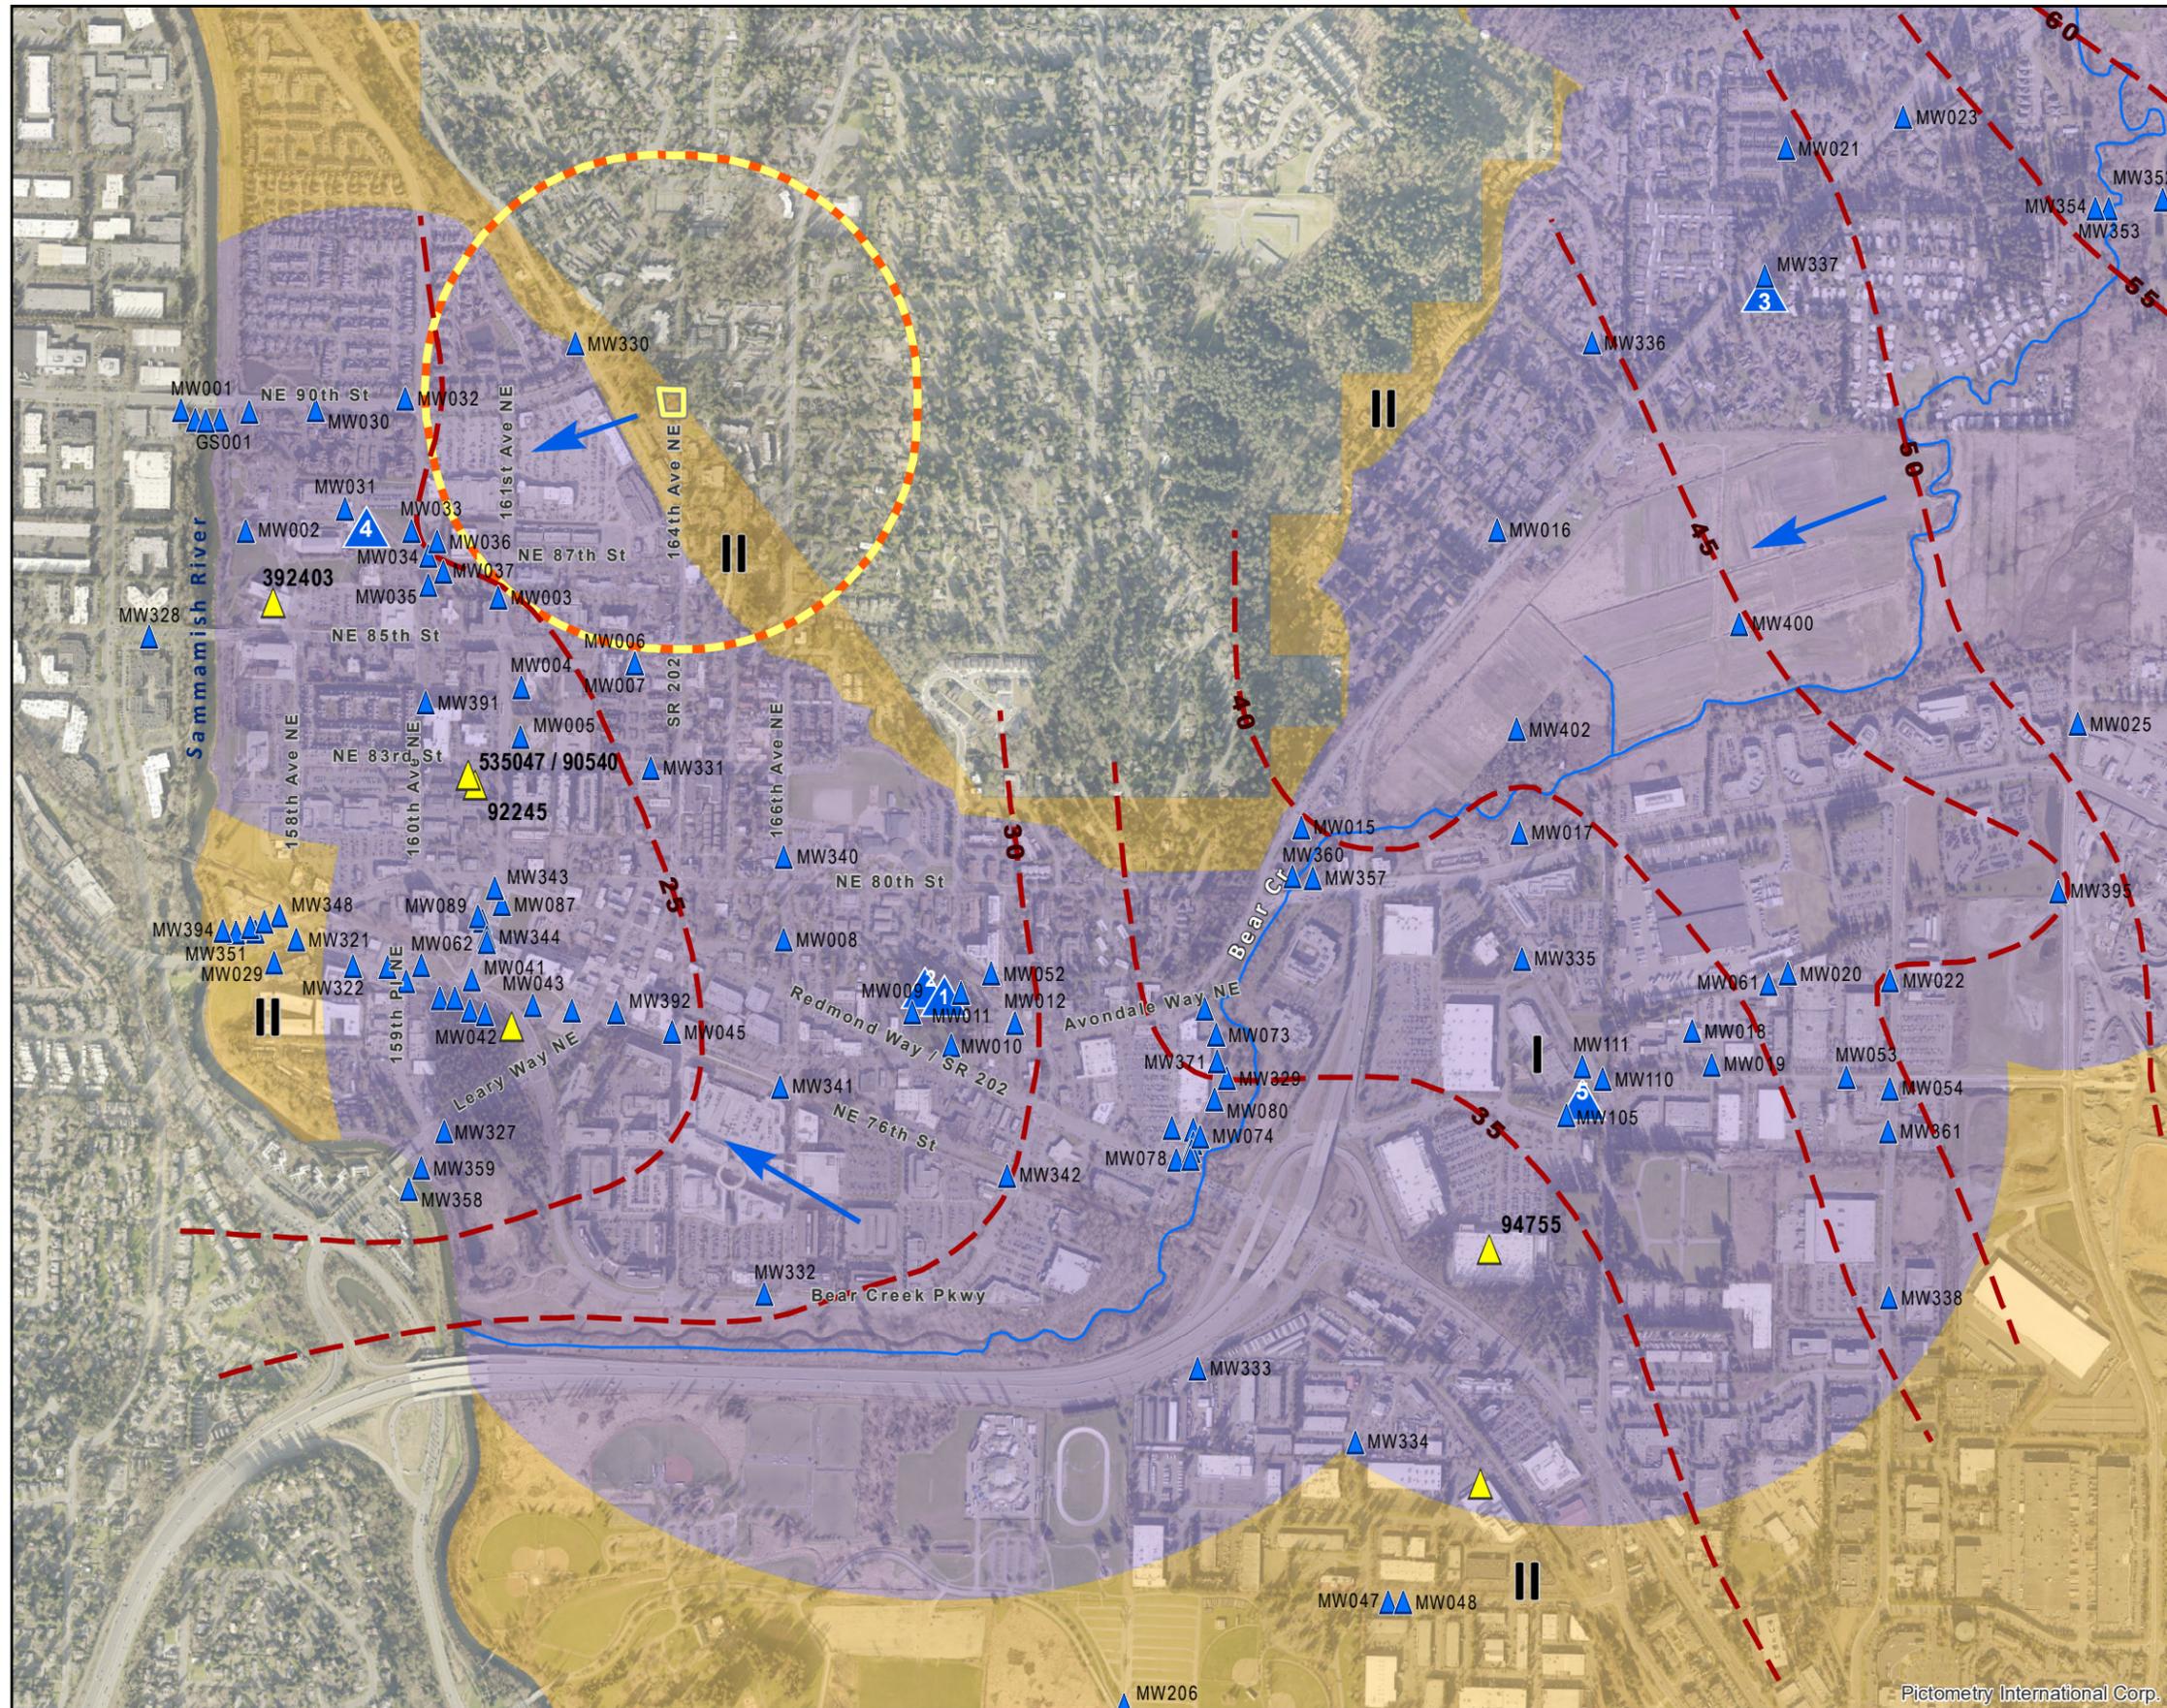
- SITE
  - 1320' SITE BUFFER
  - CITY OF REDMOND PRODUCTION WELL
  - CITY OF REDMOND MONITORING WELL
  - DOMESTIC WELL LABELED WITH DOE WELL ID
  - GROUNDWATER FLOW
  - GROUNDWATER CONTOUR
- CRITICAL AQUIFER RECHARGE AREA**
- I
  - II

WELLS:  
 MONITORING WELLS AND GROUNDWATER CONTOURS FROM: WINTER 2019 GROUNDWATER MONITORING EVENT CITY OF REDMOND WELLHEAD PROTECTION PROGRAM, DATED APRIL 30, 2019, PREPARED BY GOLDER ASSOCIATES INC. FOR CITY OF REDMOND PUBLIC WORKS DEPARTMENT  
 AERIAL: KING CO. 2015, PICTOMETRY INT

Copies of selected well/boring logs are presented in Appendix B. The approximate locations of these logs are shown on Figure 4 “Well Locations and Groundwater Contours.” Note that the limited resolution provided by the well reports typically allows water users to be located only within the nearest quarter-quarter section. Some of the well locations were refined, based on address or parcel information. It should also be noted that Ecology well reports are prepared by non-geologists and standardized geologic descriptions are not commonly utilized. Therefore, interpretations from the Ecology well reports are considered to be rough approximations and are only used to obtain a general overview of regional geologic/hydrogeologic conditions. All of the five well locations for the City water supply wells (Well Nos. 1, 2, 3, 4, and 5) as presented in City Wellhead Protection Program reports prepared by GeoEngineers, Inc. were determined to be outside the 1,300-foot radius.

We identified one City-owned monitoring well within 1,300 feet of the site (Figure 4). As noted in Section 3.3, the well was decommissioned in August 2017 (Golder, 2019a). The water well report obtained from Ecology is included in Appendix C. Two well reports for temporary dewatering wells were identified about 1,300 feet from the project site, and are included in Appendix C. These wells were not reviewed in detail due to the abundance of high-quality groundwater data from the City. It is expected that temporary construction dewatering wells have been decommissioned following completion of construction.

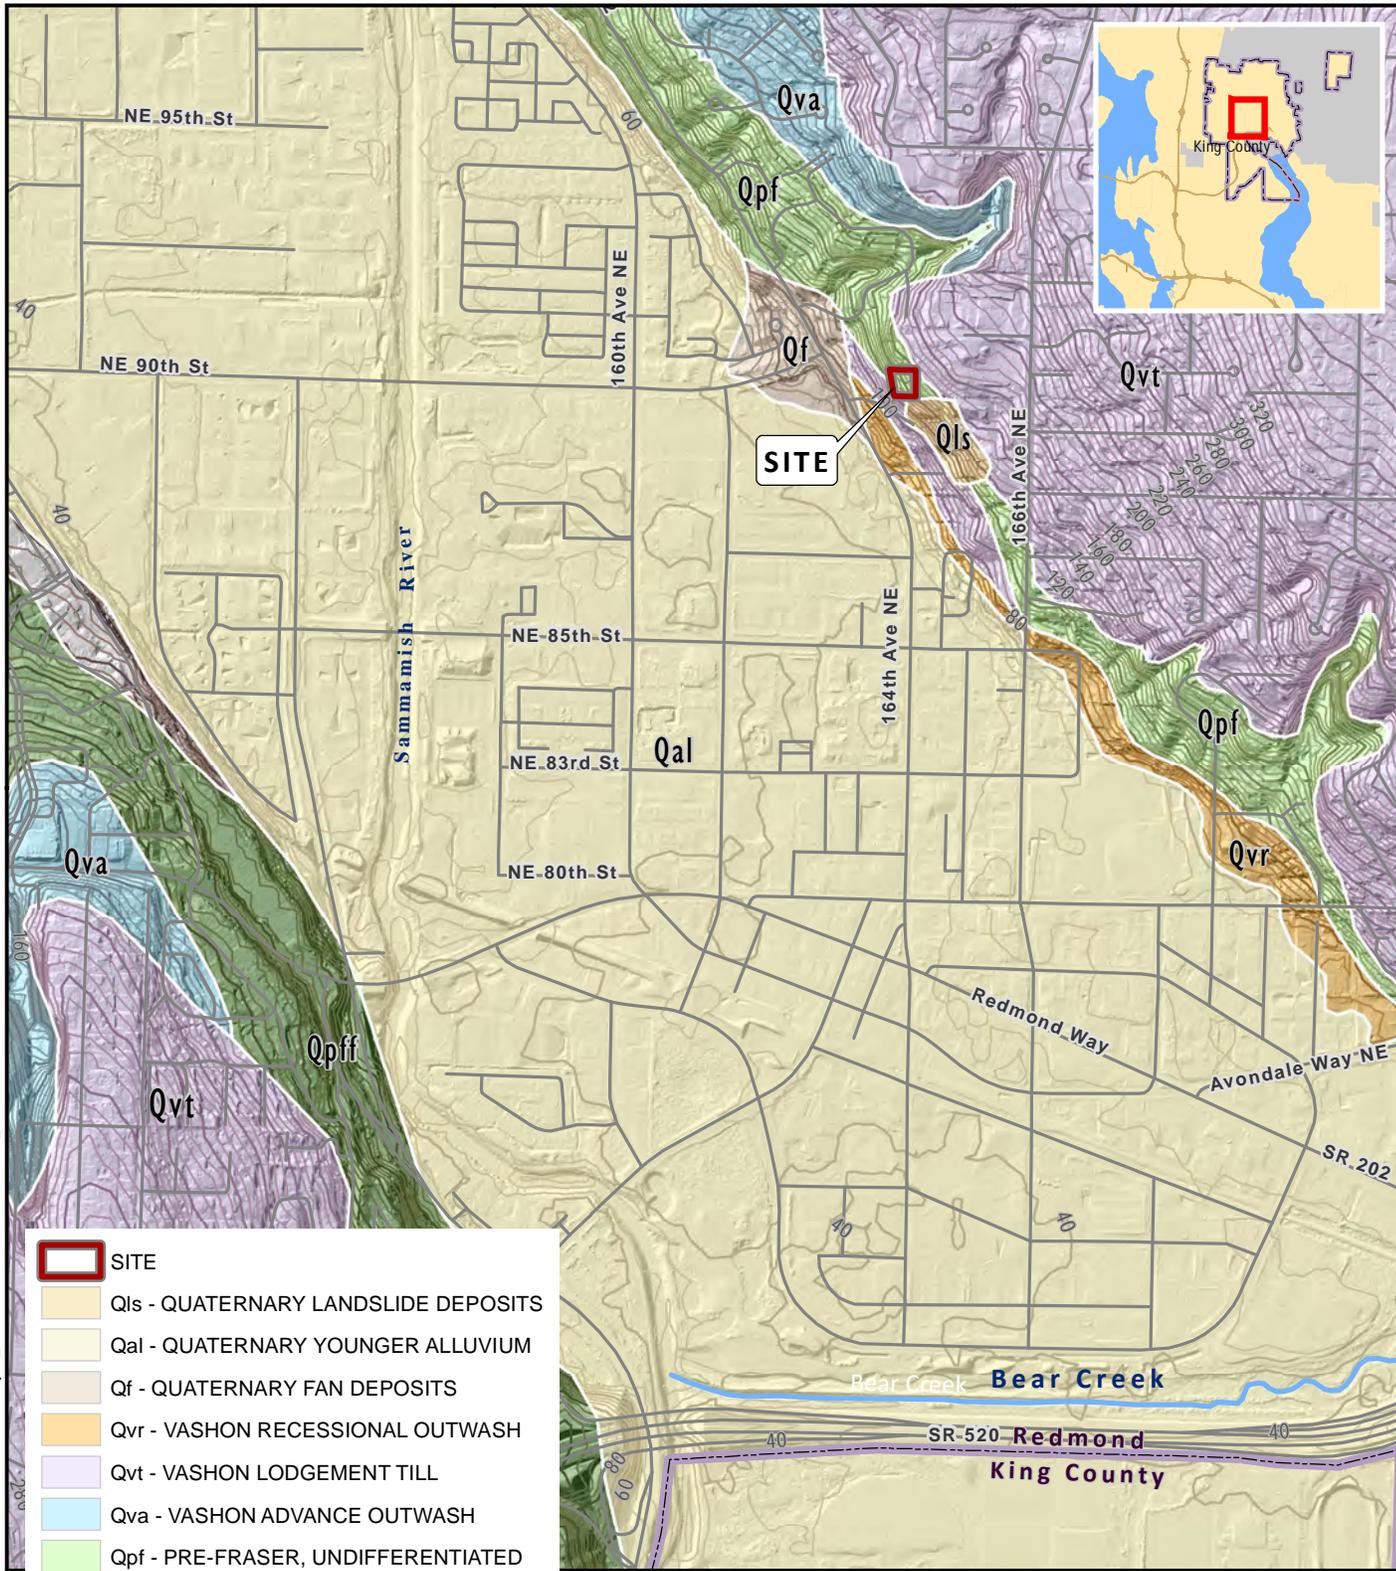
PROJ NO. 20200028H001	DATE: 2/20	FIGURE: 5
--------------------------	---------------	--------------

- SITE
- Qls - QUATERNARY LANDSLIDE DEPOSITS
- Qal - QUATERNARY YOUNGER ALLUVIUM
- Qf - QUATERNARY FAN DEPOSITS
- Qvr - VASHON RECESSIONAL OUTWASH
- Qvt - VASHON LODGEMENT TILL
- Qva - VASHON ADVANCE OUTWASH
- Qpf - PRE-FRASER, UNDIFFERENTIATED
- Qpff - PRE-FRASER, FINE GRAINED
- CONTOUR 20 FT
- CONTOUR 5 FT
- CITY BOUNDARY

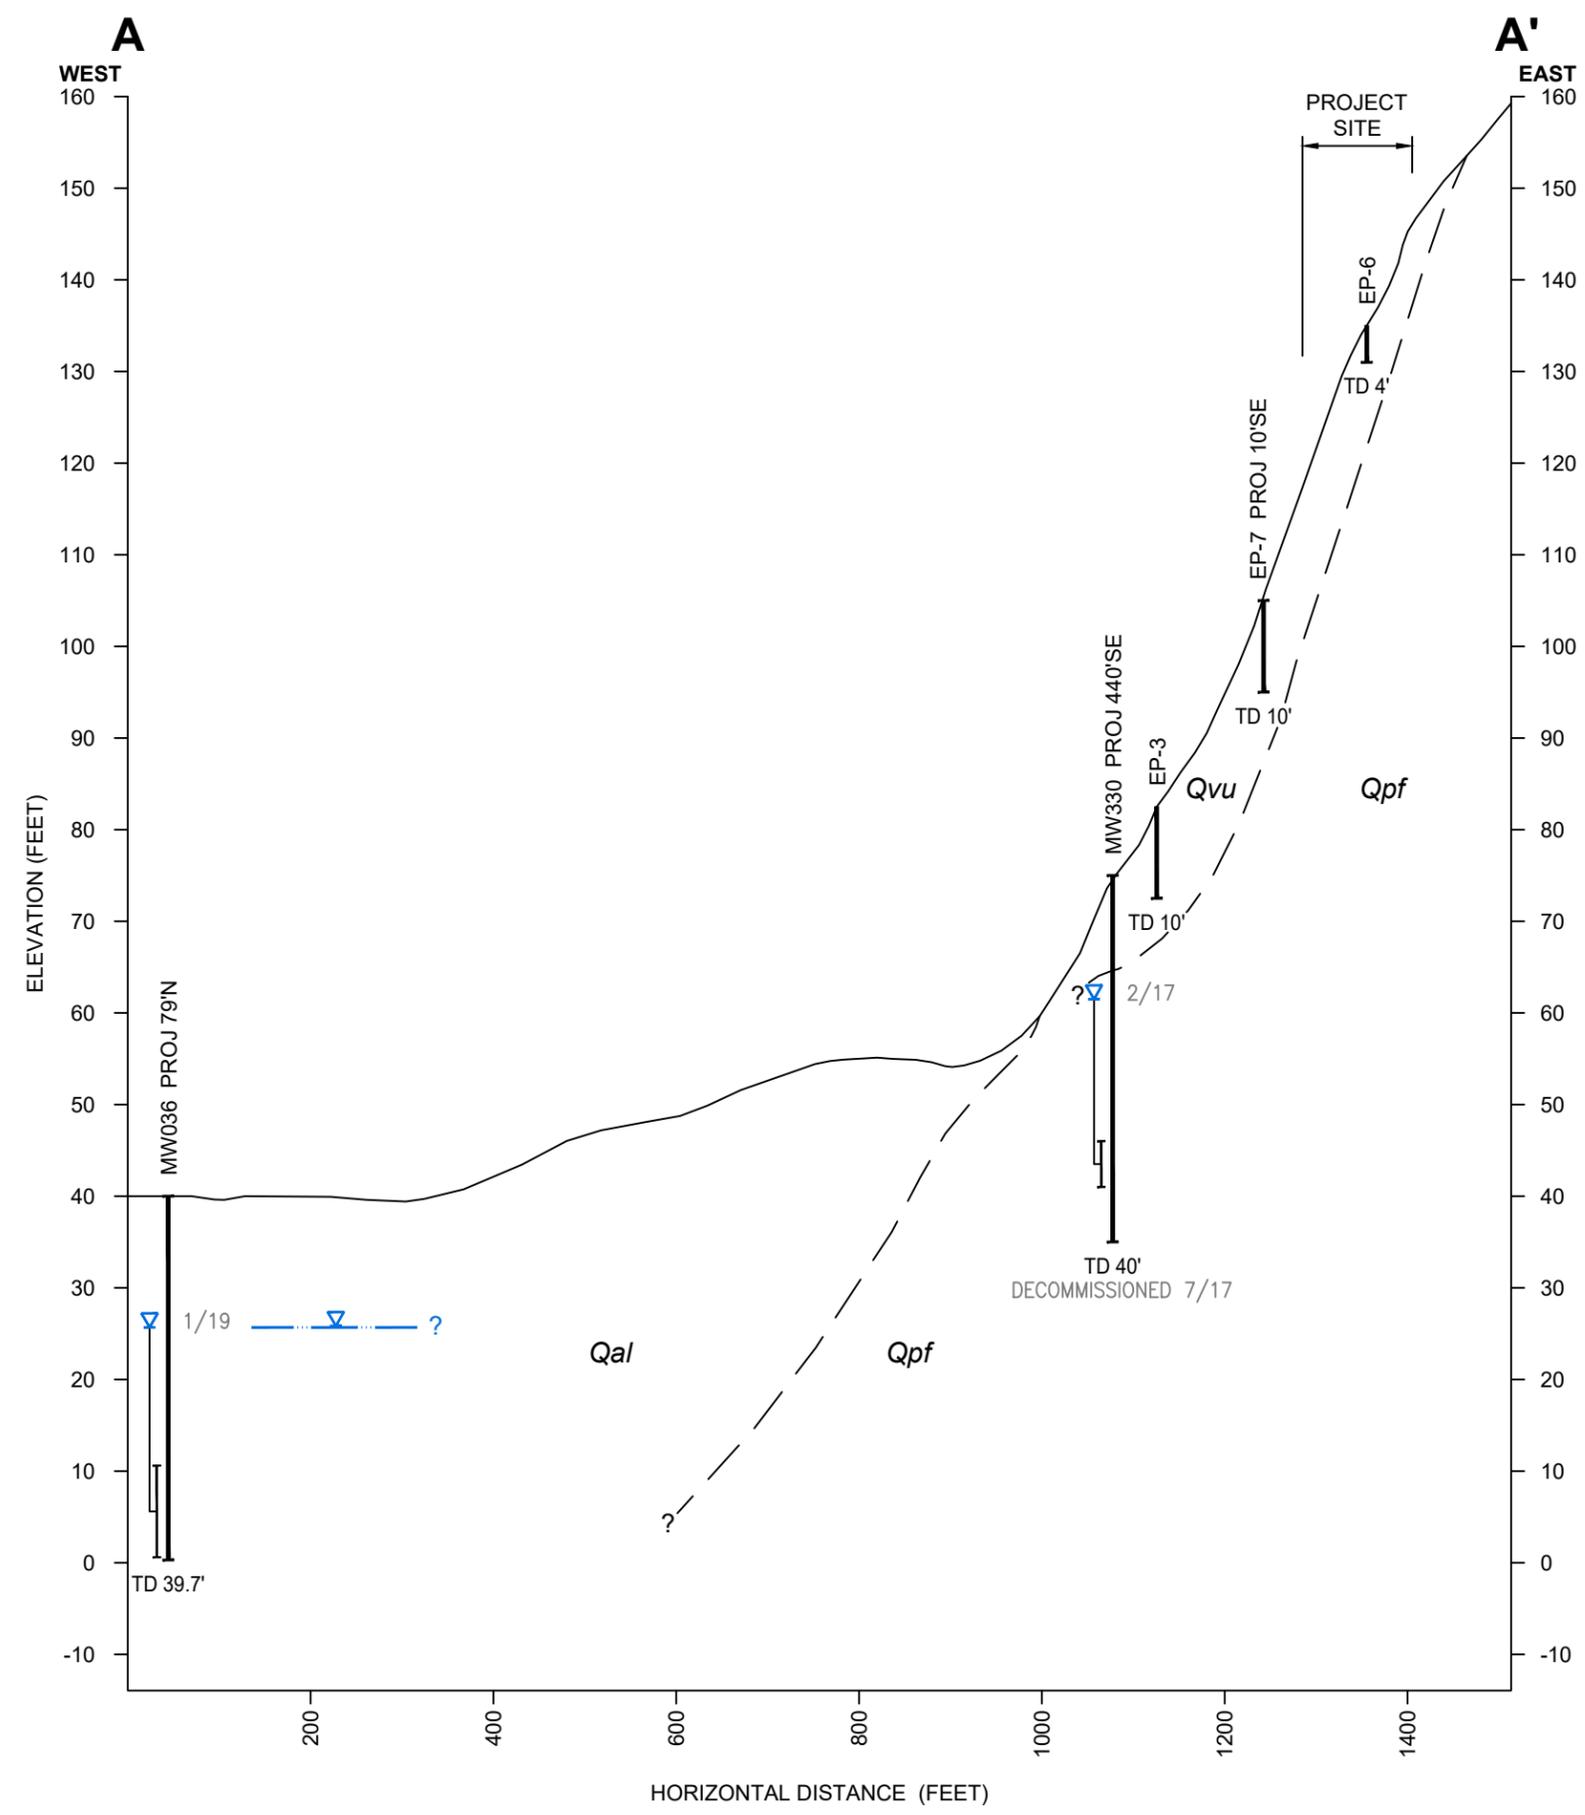
200028 Fairweather\200028 Geo Sects.dwg LAYOUT: H001 F6 Sect A-A

- Qal* QUATERNARY YOUNGER ALLUVIUM
- Qvu* VASHON-AGE DEPOSITS - UNDIFFERENTIATED
- Qpf* PRE-FRASER DEPOSITS - UNDIFFERENTIATED
- ┆ EXPLORATION  
EP = EXPLORATION PIT  
MW = MONITORING WELL
- ▽ STATIC WATER LEVEL
- ▽ — INFERRED GROUNDWATER TABLE
- ┆ SCREENED INTERVAL
- TD TOTAL DEPTH OF BORING
- - - GEOLOGIC CONTACT

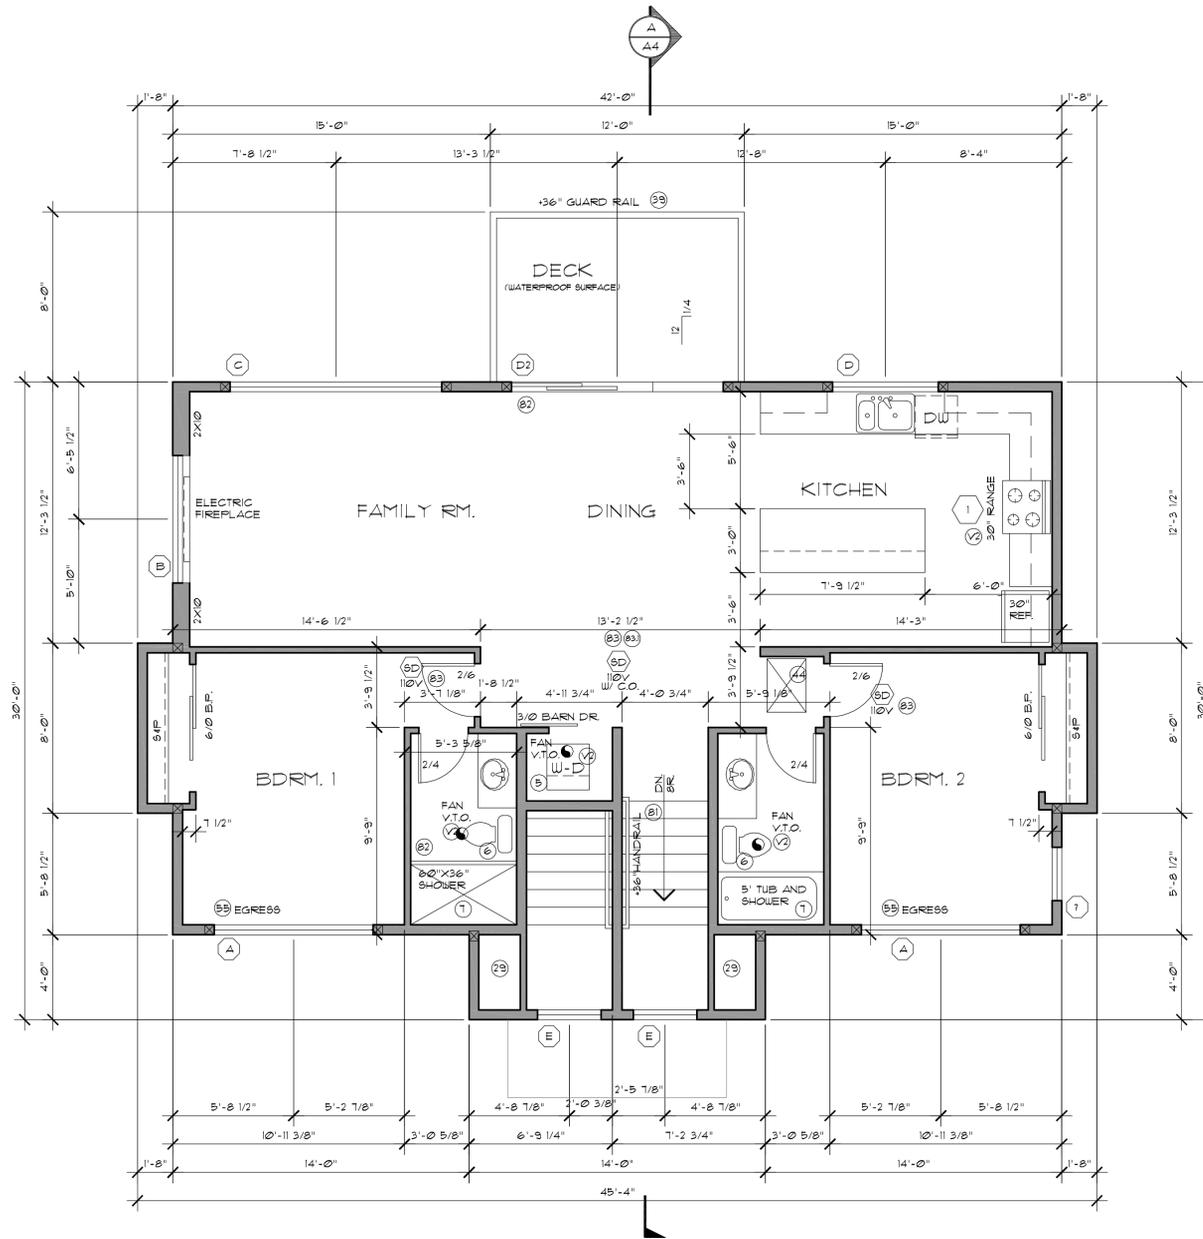
UPPER FLOOR PLAN (9004)  
SCALE: 1/4" = 1' - 0"

SEE GENERAL NOTES SHEET  
8' DOOR HT. (TYP. UNO.)  
95" WINDOW HEADER HEIGHT (TOP FLOOR ONLY)  
PROVIDE FRESH AIR PORT IN HABITABLE ROOMS

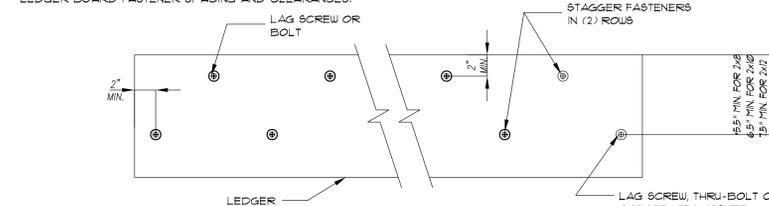
LEDGER CONNECTION DETAIL  
N.T.S.

\*DISTANCE CAN BE REDUCED TO 4.5" IF LAG SCREWS ARE USED OR IF BOLT SPACING IS REDUCED TO THAT OF LAG SCREWS TO ATTACH 2X8 LEDGERS TO 2X8 BAND JOISTS.

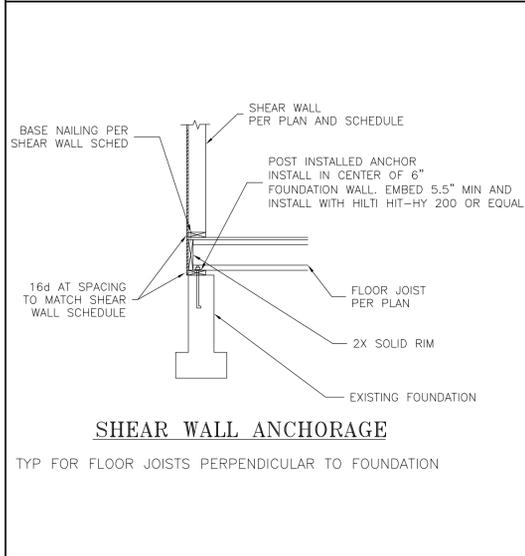
SHEAR WALL ANCHORAGE

TYP FOR FLOOR JOISTS PERPENDICULAR TO FOUNDATION

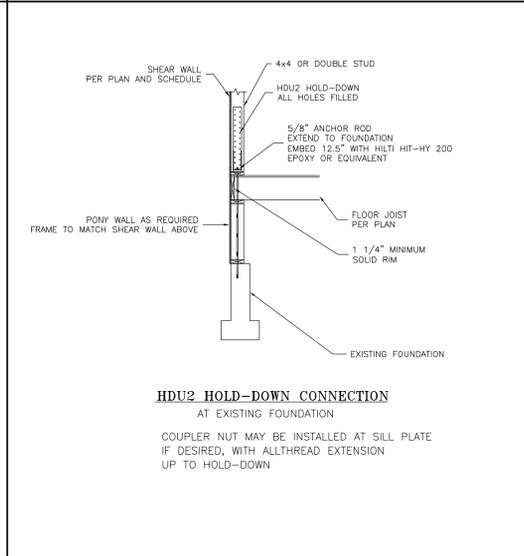
HDU2 HOLD-DOWN CONNECTION

AT EXISTING FOUNDATION  
COUPLER NUT MAY BE INSTALLED AT SILL PLATE IF DESIRED, WITH ALLTHREAD EXTENSION UP TO HOLD-DOWN

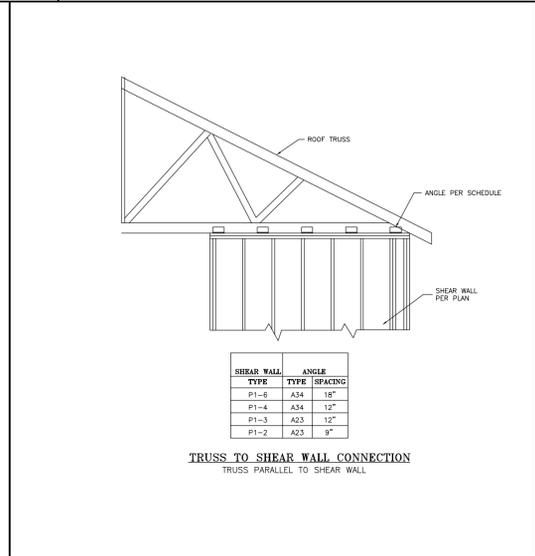
TRUSS TO SHEAR WALL CONNECTION

SHEAR WALL TYPE	ANGLE TYPE	ANGLE SPACING
P1-6	A34	18"
P1-4	A34	12"
P1-3	A23	12"
P1-2	A23	9"

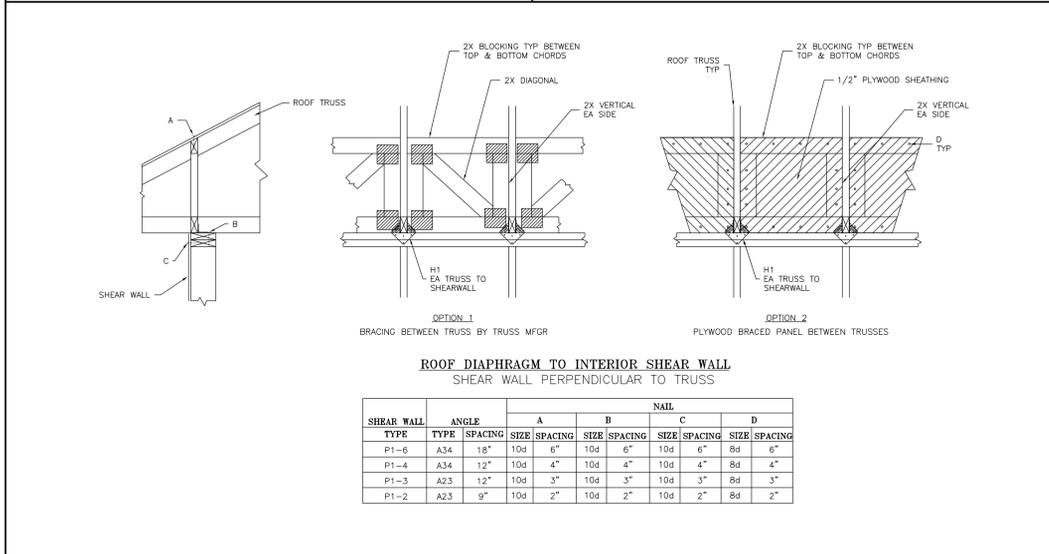
ROOF DIAPHRAGM TO INTERIOR SHEAR WALL

SHEAR WALL TYPE	ANGLE TYPE	ANGLE SPACING	NAIL							
			A		B		C		D	
TYPE	TYPE	SPACING	SIZE	SPACING	SIZE	SPACING	SIZE	SPACING	SIZE	SPACING
P1-6	A34	18"	10d	6"	10d	6"	10d	6"	8d	6"
P1-4	A34	12"	10d	4"	10d	4"	10d	4"	8d	4"
P1-3	A23	12"	10d	3"	10d	3"	10d	3"	8d	3"
P1-2	A23	9"	10d	2"	10d	2"	10d	2"	8d	2"

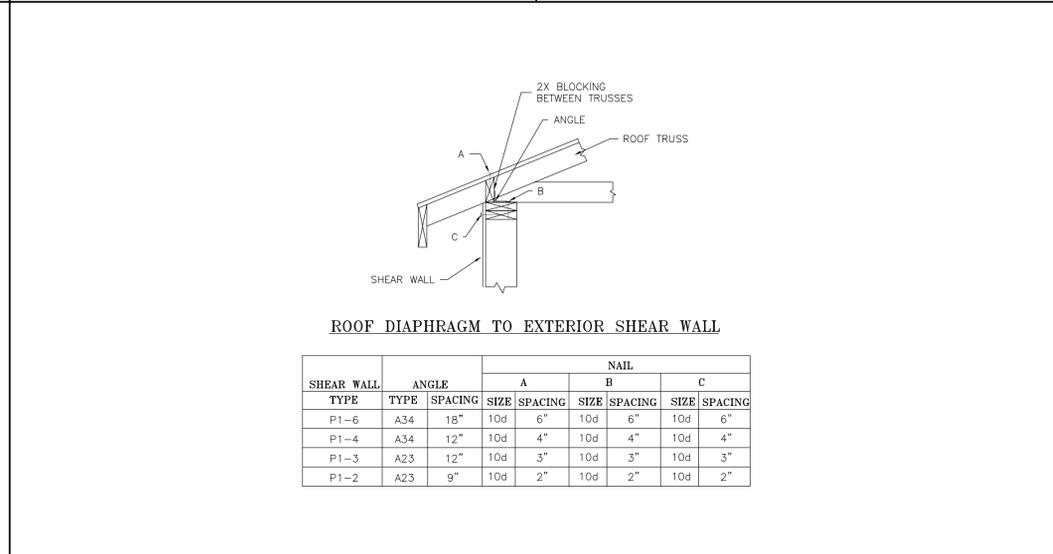
ROOF DIAPHRAGM TO EXTERIOR SHEAR WALL

SHEAR WALL TYPE	ANGLE TYPE	ANGLE SPACING	NAIL					
			A		B		C	
TYPE	TYPE	SPACING	SIZE	SPACING	SIZE	SPACING	SIZE	SPACING
P1-6	A34	18"	10d	6"	10d	6"	10d	6"
P1-4	A34	12"	10d	4"	10d	4"	10d	4"
P1-3	A23	12"	10d	3"	10d	3"	10d	3"
P1-2	A23	9"	10d	2"	10d	2"	10d	2"

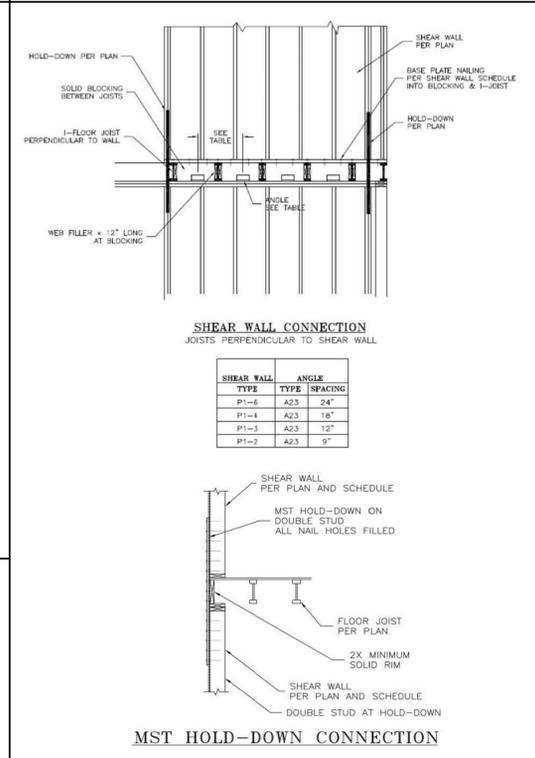
SHEAR WALL CONNECTION

SHEAR WALL TYPE	ANGLE TYPE	ANGLE SPACING
P1-6	A23	24"
P1-4	A23	18"
P1-3	A23	12"
P1-2	A23	9"

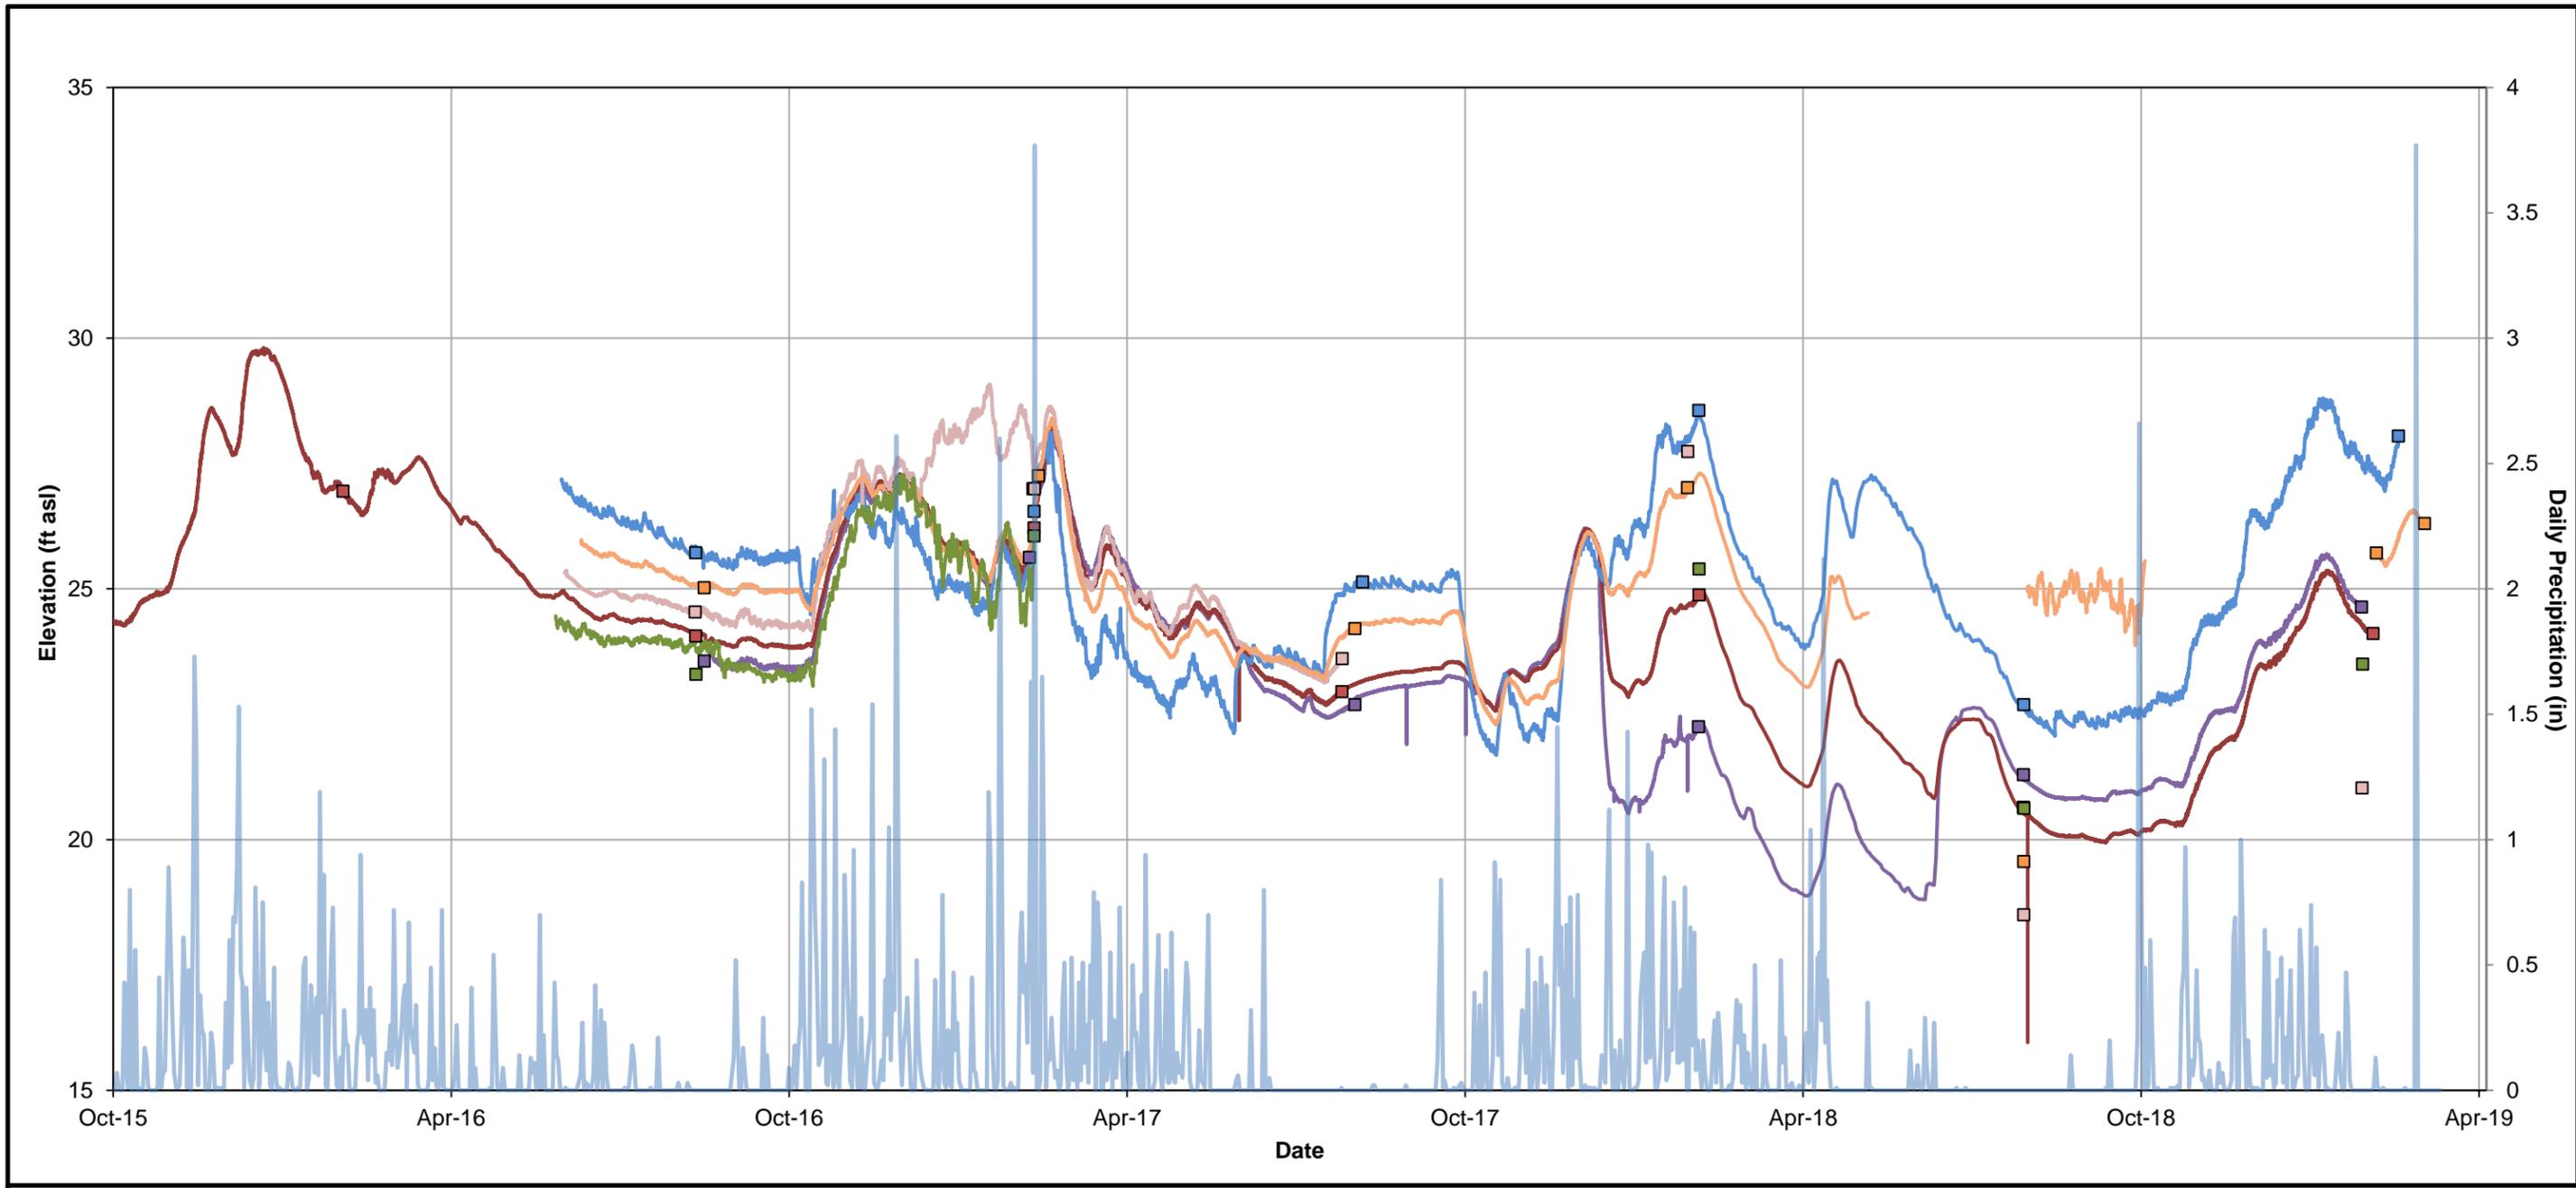
FIGURE **2C**

Notes:  
 1. The MW089 transducer stopped responding and was removed.
