# FAIRWEATHER DUPLEX CRITICAL AREAS REPORT

**PROJECT:** Fairweather Duplex

## *Critical Aquifer Recharge Area Evaluation*

### **FAIRWEATHER DUPLEX**

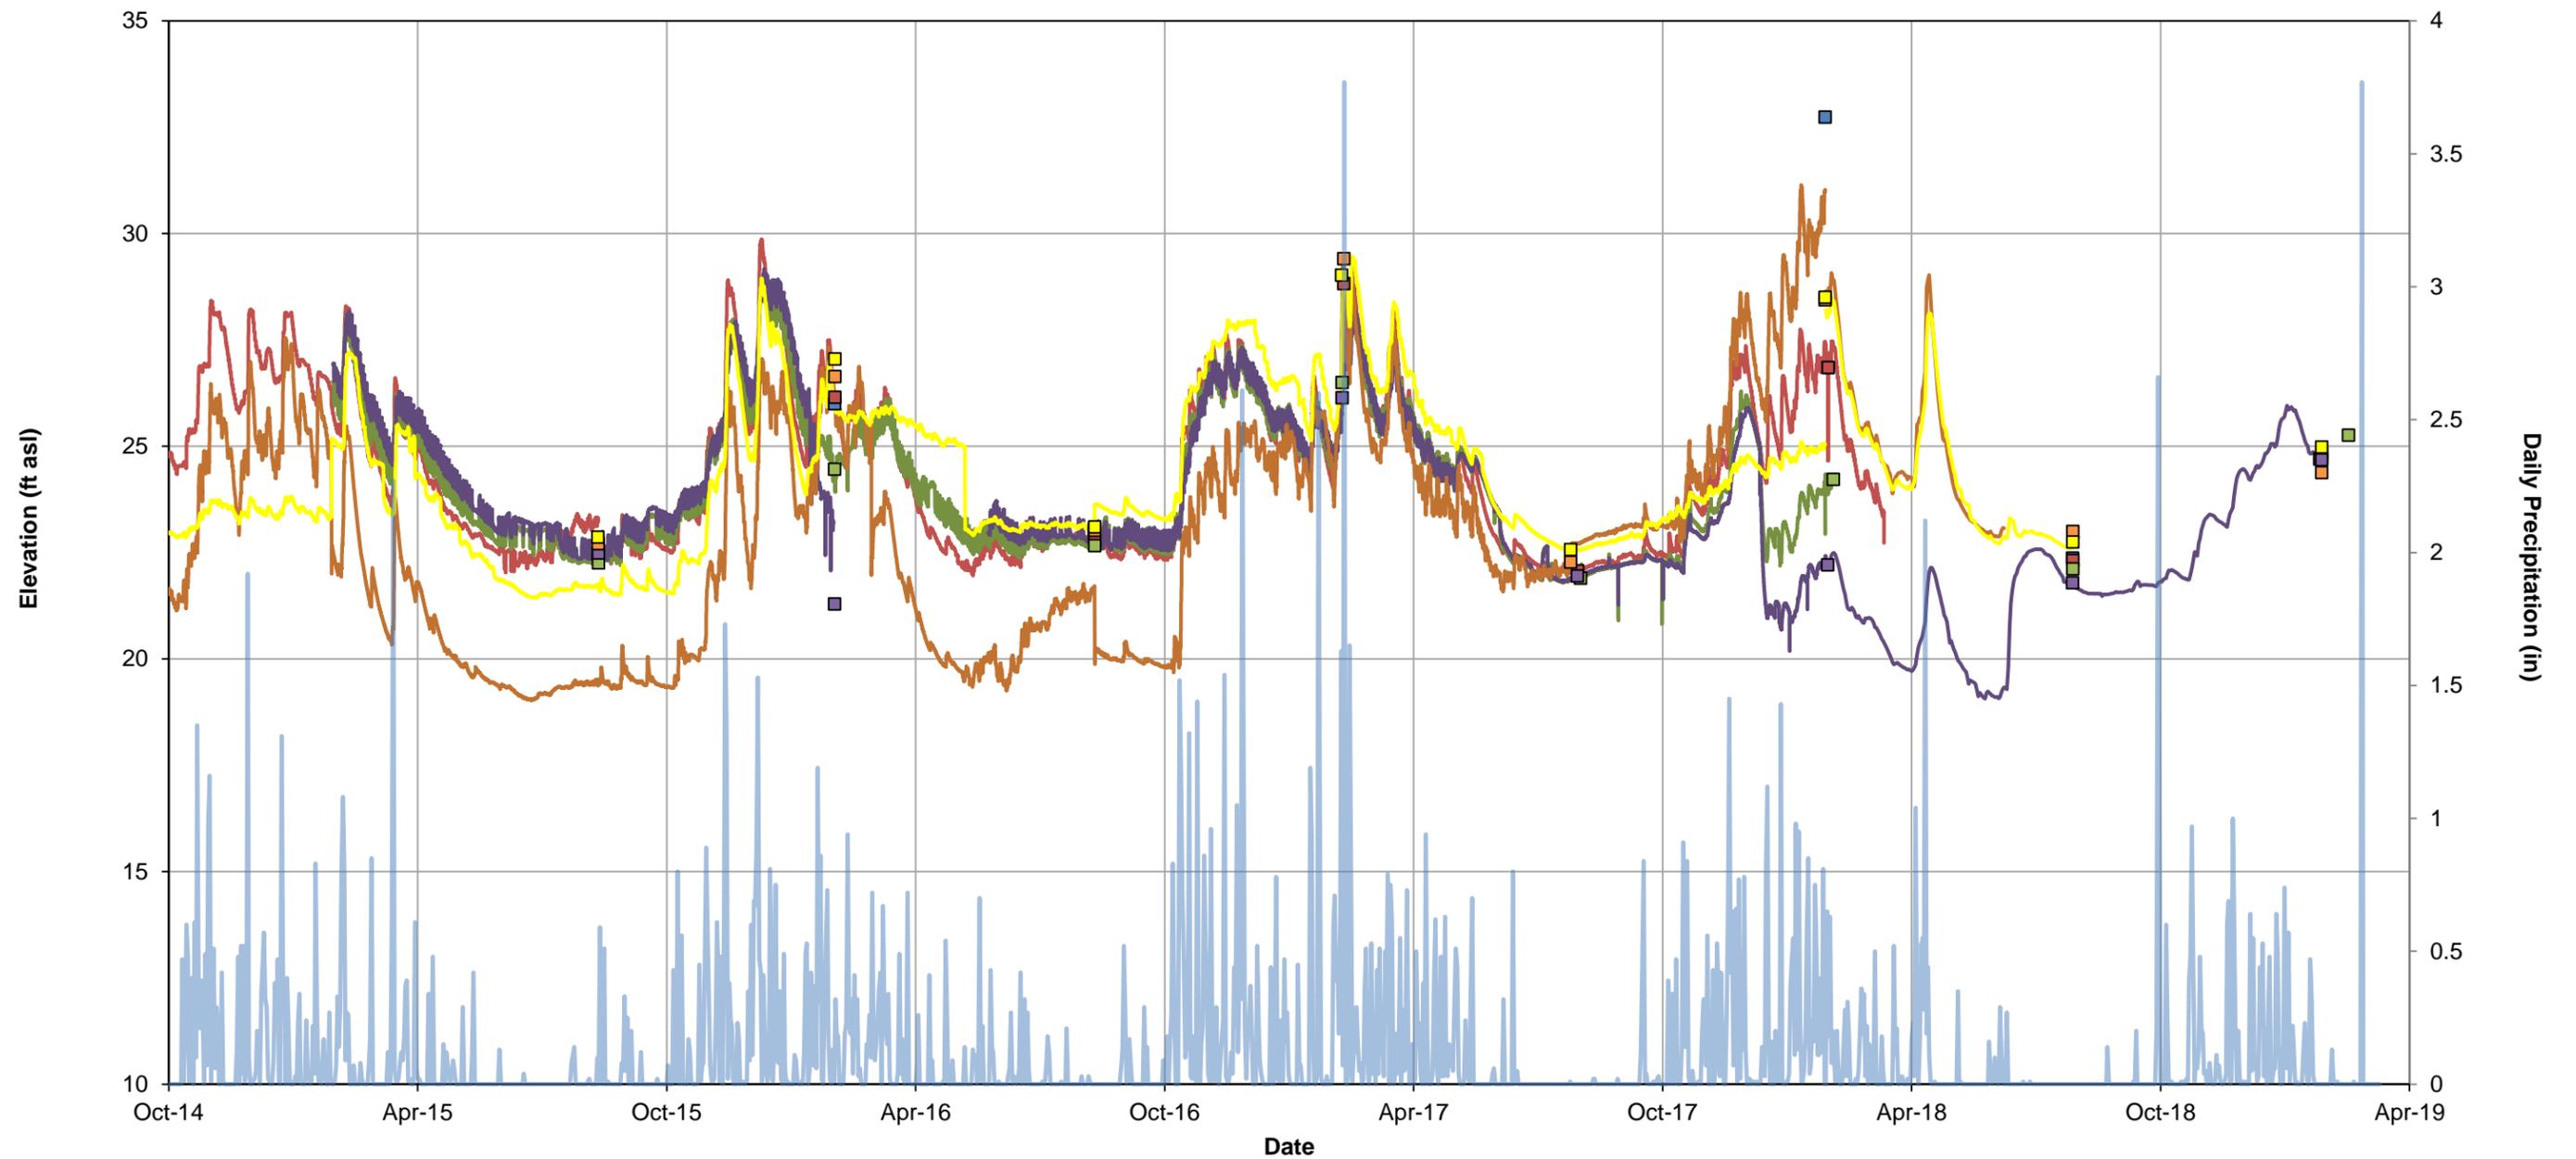
1. The MW002 transducer was removed on 8/17/16.
2. The pressure transducer in MW328 detached from the well cap and sunk to the bottom of the well in June 2018. It was retrieved by the City of Redmond on 7/31/2018 and reinstalled by Golder. Data are not available from June 10 to July 31, 2018.
