Critical Areas Report

Hopelink Redmond Integrated Service Center
Redmond, Washington

October 2016
PBS Project # 41342

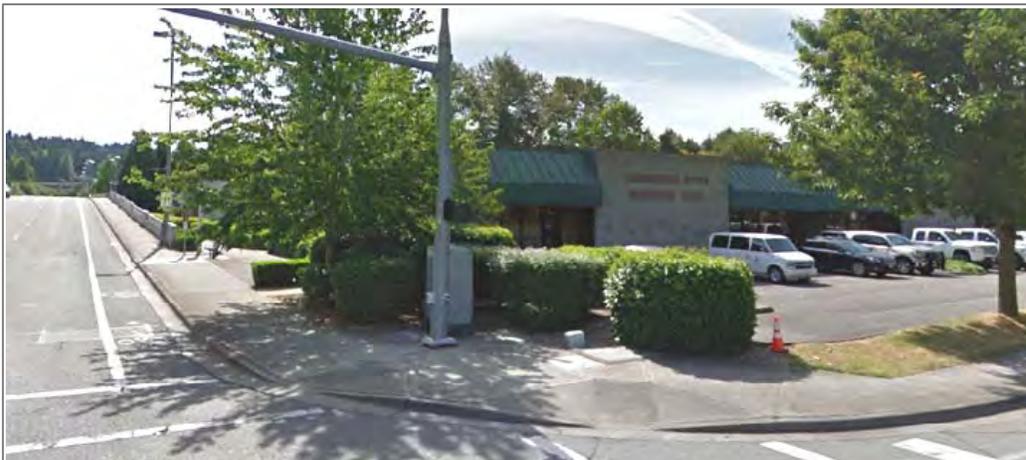
View of existing site from intersection of NE 90th Street and 154th Avenue NE

The two buildings occupy approximately 46 percent of the site. Parking lots and sidewalks occupy an addition 43 percent for a total of 89 percent impervious surface.

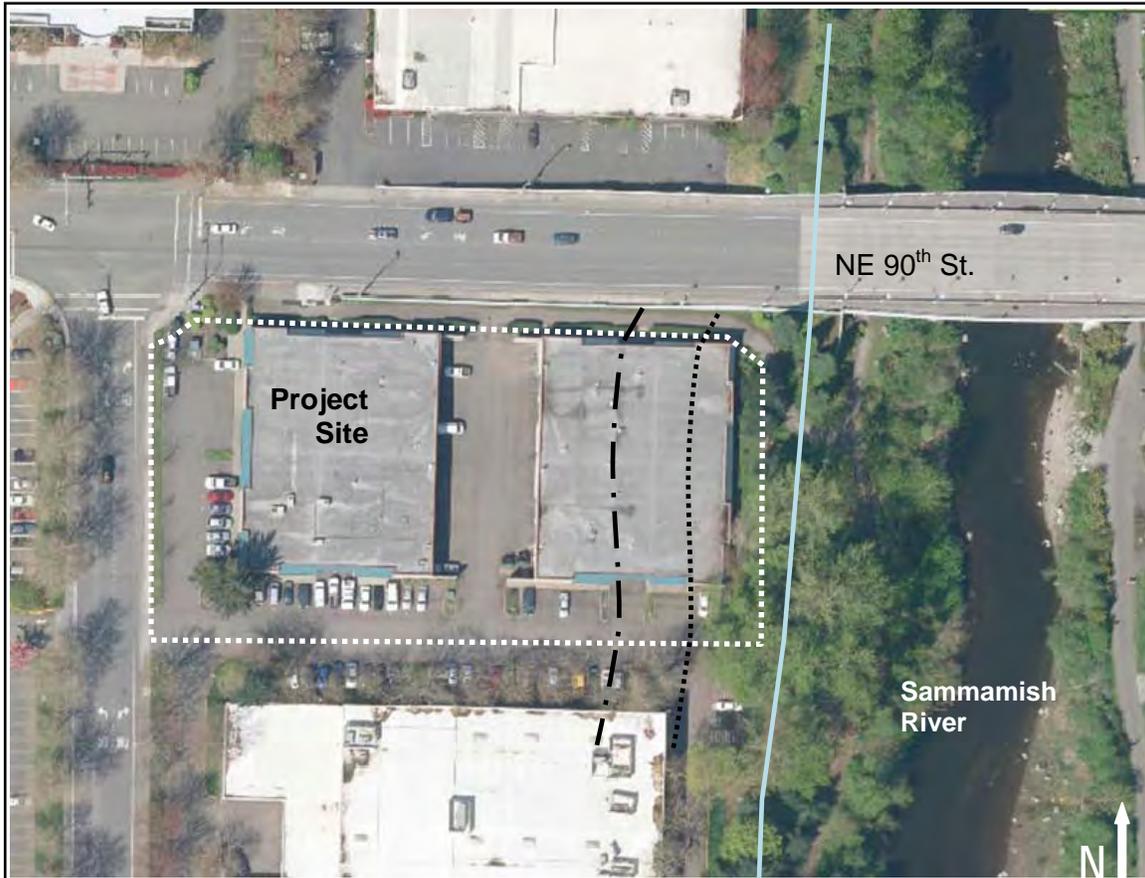
CRITICAL AREAS

Entire parcel is in 100 Yr Floodplain

200' Shoreline Zone

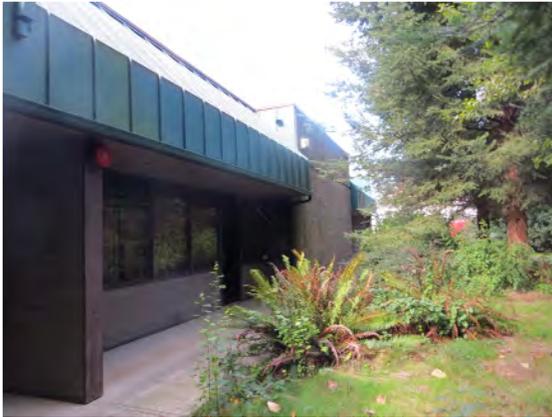
Photo 1. View to north of east edge of parcel with existing building, sidewalk and planted berm with swordferns in the foreground and Douglas-firs in the background.

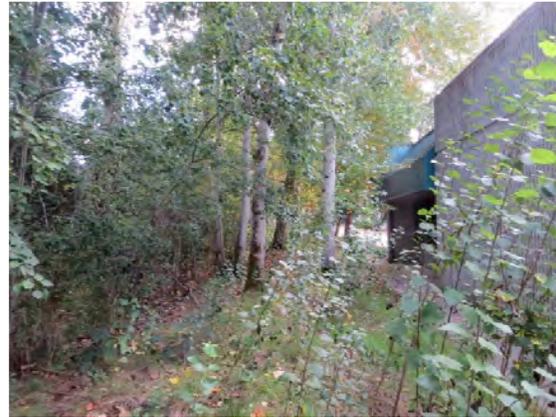
Photo 2. View to south of berm with quaking aspen seedlings in foreground and planted maple and older aspens in background. Maple and older aspens to be removed per arborist.

An evaluation of the trees on or adjacent to the property by a certified arborist identified several trees that potentially pose a danger to life or property and were recommended for removal. Trees within the stream buffer on the property that are recommended for removal include four quaking aspens and a non-native red maple.

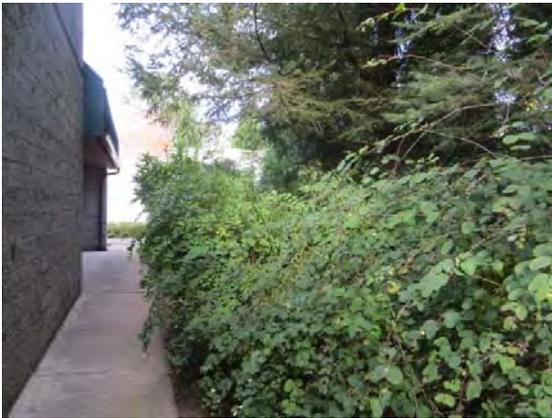
Photo 3. View of northern part of berm with planted snowberries and tall Oregon grape. Most berm plantings will be preserved.

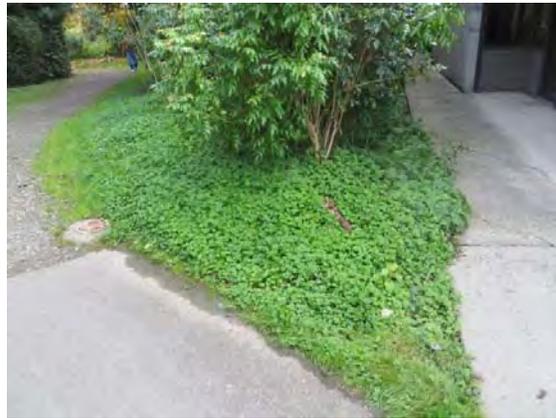
Photo 4. View to south of northeast corner of property showing sidewalk and building on right and King County Trail on left.

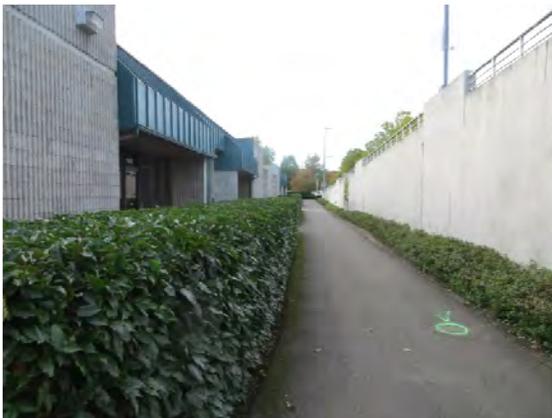
Photo 5. View to west of North end of lot showing King County trail and retaining wall below NE 90th St. After boundary line adjustment, parcel will end at south edge of trail

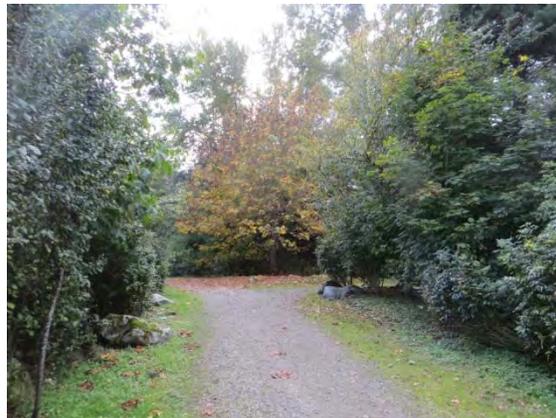
Photo 6. View to north of King County trail through stream buffer.

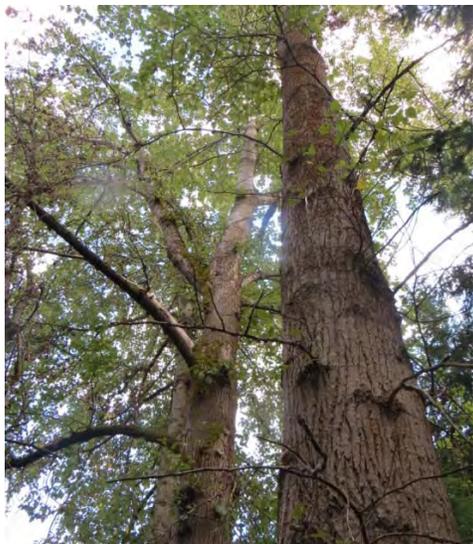
Photo 7. Large cottonwoods at southeast corner of property

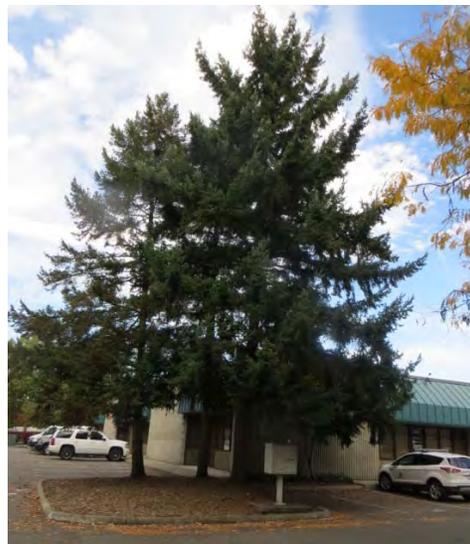
Photo 8. Three Douglas firs in southwest corner to remain if possible.

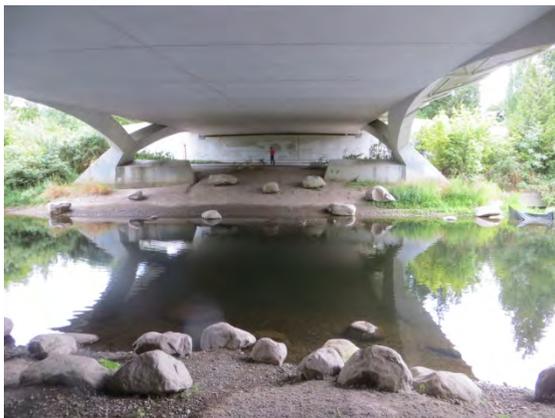
Photo 9. View of river under the NE 90th Street Bridge

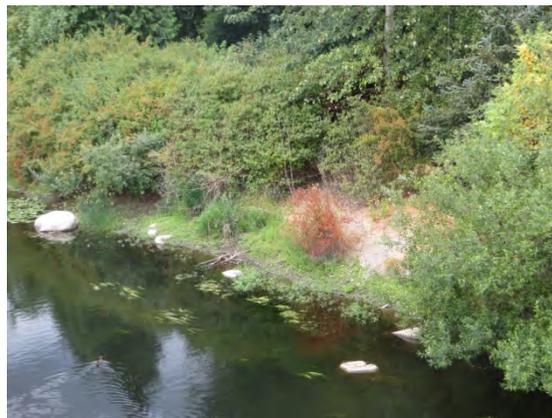
Photo 10. View to southwest from the bridge of shoreline near property showing maturing plantings

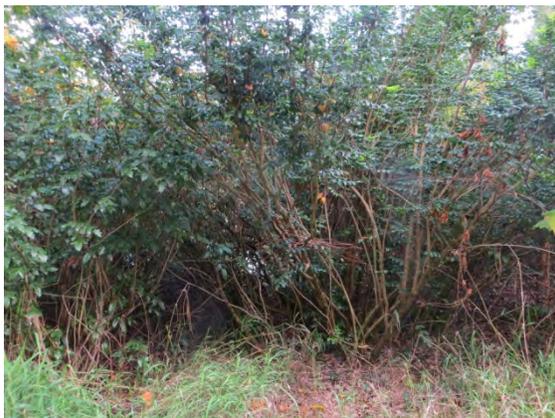
Photo 11. View of riparian corridor east of trail with dense bitter cherry and tall Oregon grape

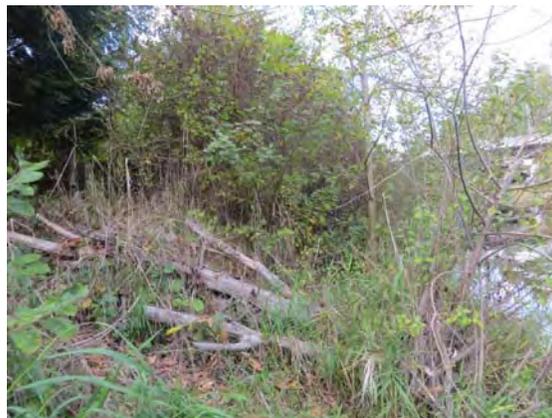
Photo 12. View of riparian corridor along river with planted willows and large wood placement.
