**Arborist Report
for
Garbarino Property
Parcels 1246700321 and 1246700329
Redmond, WA**

**November 12, 2015
Updated 2-8-16
Updated 7-31-18**

American Forest Management was contacted by Greg Arms of Milestone NW and was asked to compile an 'Arborist Report' for a subdivision project involving two parcels in the City of Redmond. The parcel numbers are 1246700321 and 1246700329.

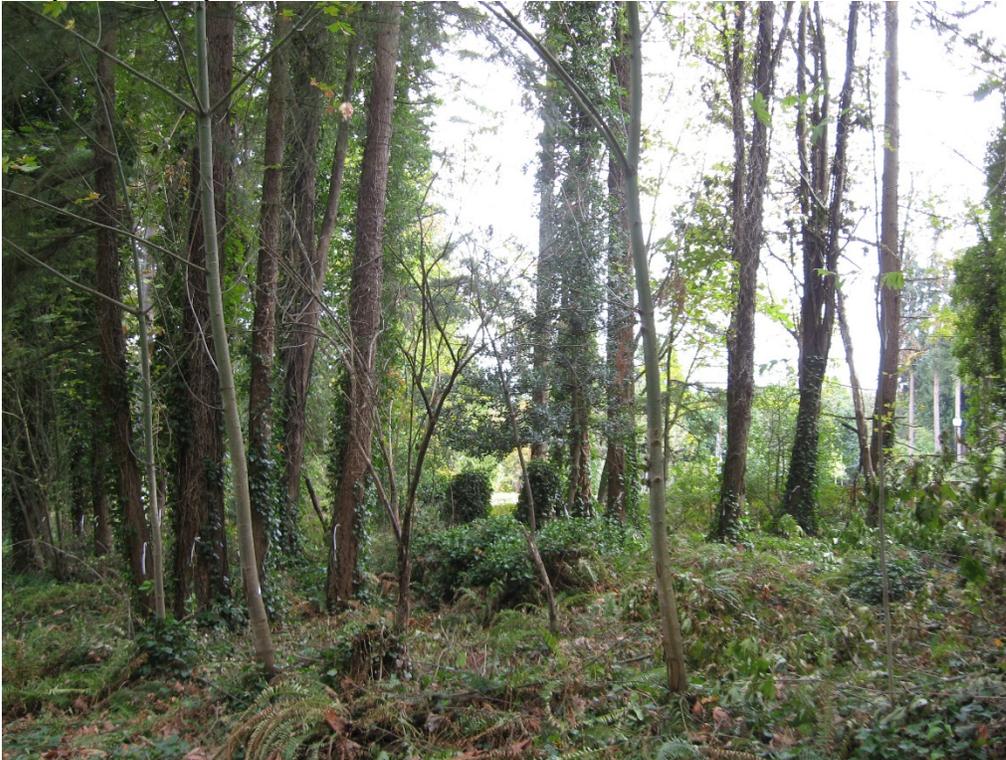
Subject Property – South Side

The big leaf maples on the property vary in condition and viability. Several recently suffered major branch and stem failures during the August 29th windstorm. A few have significant infections of *Kretzschmaria deusta*, a soft rot fungus. Many are in decline evidenced by significant dieback of upper crown components and thinning foliage (sparse crowns).

Recent co-dominant stem failure on big leaf maple

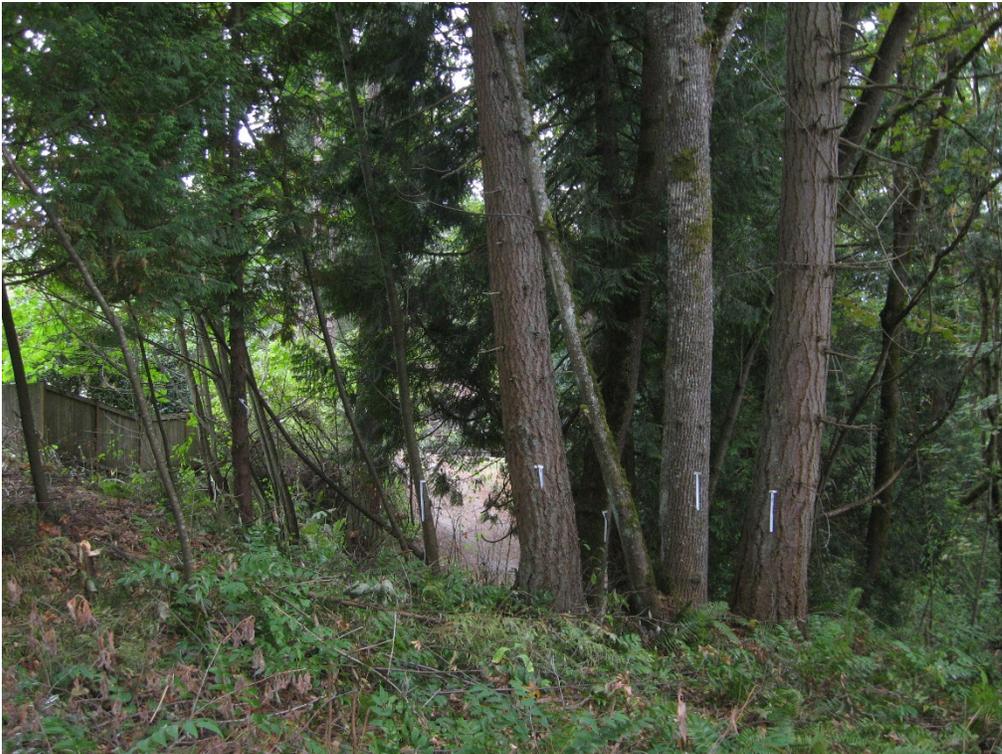
East end

Previously cleared area on east side of property – non-significant alder
