AMERICAN FOREST
MANAGEMENT

**Arborist Report
for
G.W. Williams Co.
7440 159th Pl. NE. Redmond, WA**

**March 4, 2019
UPDATED March 18, 2020**

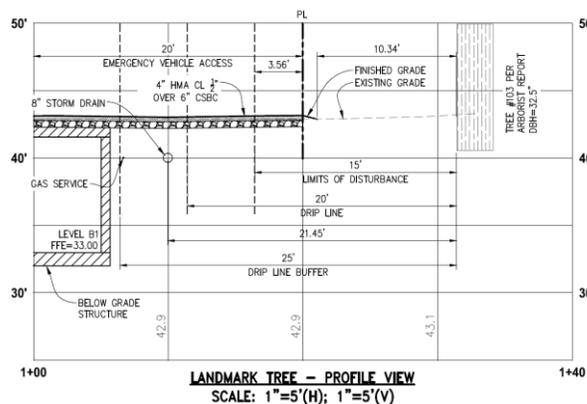
Tree #103 is a 123 foot tall Douglas fir in good condition with codominant stems of 31 inches and 34 inches joined below 4.5 feet for an average DBH of 32.5 inches earning it 'Landmark' status.

The proposed plan requires an Emergency Vehicle Access lane (EVA) approximately 10.5 feet west of Tree #103. Pavement from the existing parking lot currently extends to 3 feet west of this tree. This pavement will need to be carefully removed to prevent damaging roots found below. The grading and installation of this access lane should be accomplished in a way to minimize excavation or compaction which will lead to loss of roots within the CRZ. Utilizing a Cellular Confinement System (CCS) within the 6 inch CSBC layer shown in the profile view below will minimize compaction to this tree’s CRZ. Further information regarding benefits and installation of CCS are outlined in the attached Site Guidance Note.

A storm drain pipe is proposed to be installed within the 5 foot dripline buffer west of Tree #103. All associated catch basins are planned to be installed outside of this dripline buffer. Large structural roots are not likely to be found in this far west of Tree #103 below the existing paved parking area. This installation is unlikely to negatively affect this tree if all tree protection measures outlined below are adhered to.
