# Larkin Subdivision

City of Redmond, Washington

## Preliminary Storm Drainage Report

Prepared for  
Rose Hill 12, LLC  
2630 116<sup>th</sup> Ave NE, Suite 200  
Bellevue, WA 98004

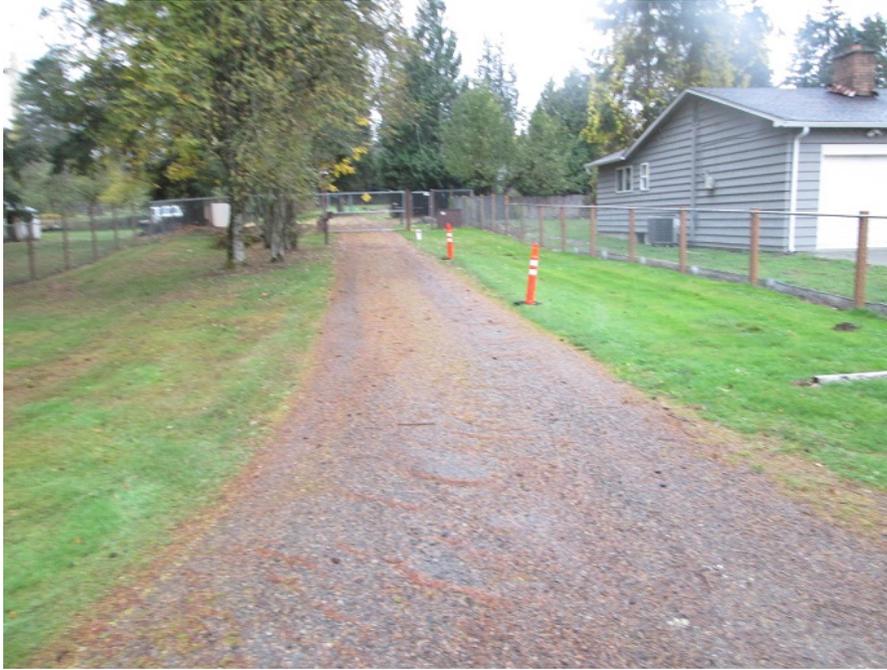
Photo 1 - Looking west - Runoff sheet flows southeast from the site.

Runoff from the site sheet flows south and east (Photo 1) and is collected in the public drainage ditch along 134<sup>th</sup> Ave NE. Flows are then conveyed along the drainage ditch on the west side of 134<sup>th</sup> Ave NE (Photo 2) where they continue south for approximately 600 ft through the ditch and driveway culverts. Flows then enter a tight-lined drainage system (Photo 3) and are routed east to the NE corner of NE 100<sup>th</sup> St and 134<sup>th</sup> Ave NE. (Photo 4). Flows continue east to a catch basin where flows are piped across NE 100<sup>th</sup> St (Photo 5). Flows outfall to a natural drainage channel where it continues for approximately 700 ft to the  $\frac{1}{4}$  mile downstream point.

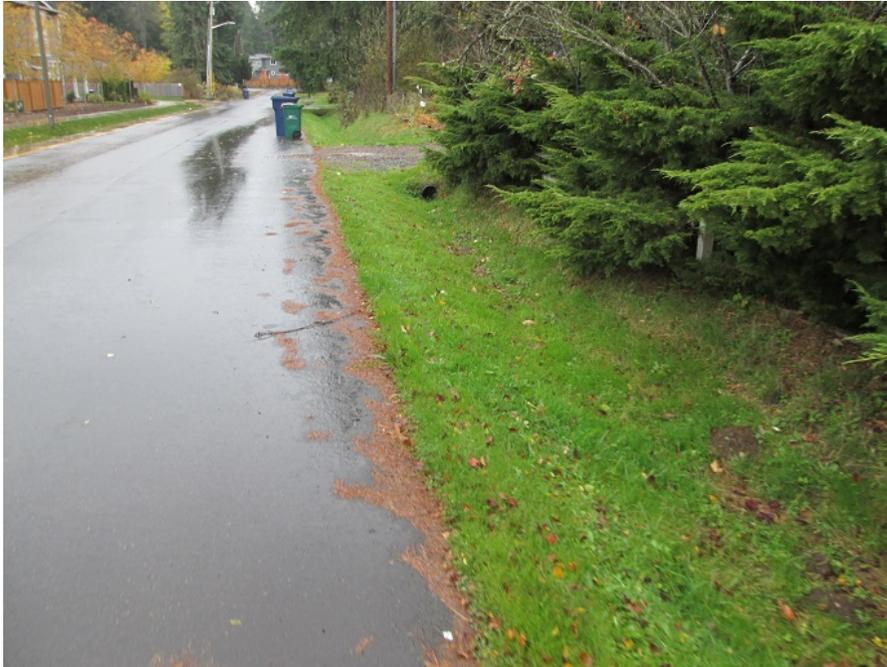
Photo 2 - Looking south - Flows are collected in the drainage ditch on the west side of 134<sup>th</sup> Ave NE where they are conveyed south (~600 ft) through a series of driveway culverts.

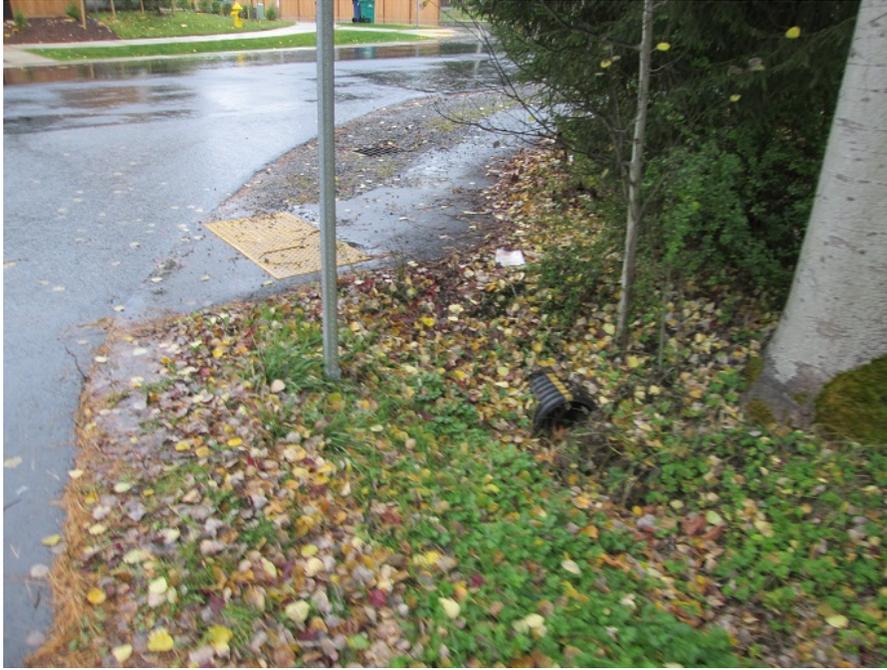
Photo 3 – Looking southwest – Flows enter the tight line system through this culvert and are conveyed south to the catch basin in the gravel.

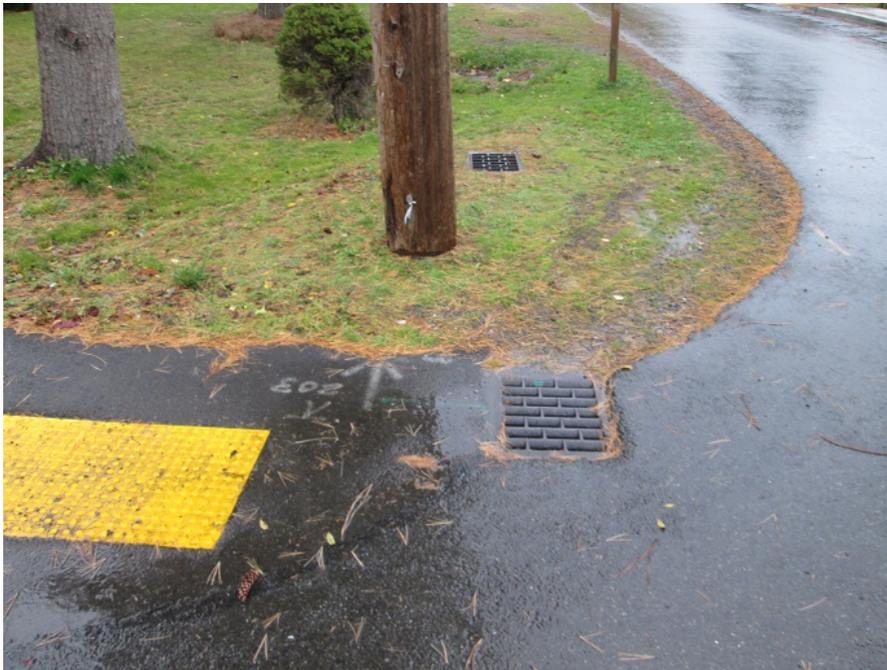
Photo 4 – Looking east – Flows are conveyed east to this catch basin on the east side of 134<sup>th</sup> Ave NE, and continue through to the next two catch basins as shown in the photo.

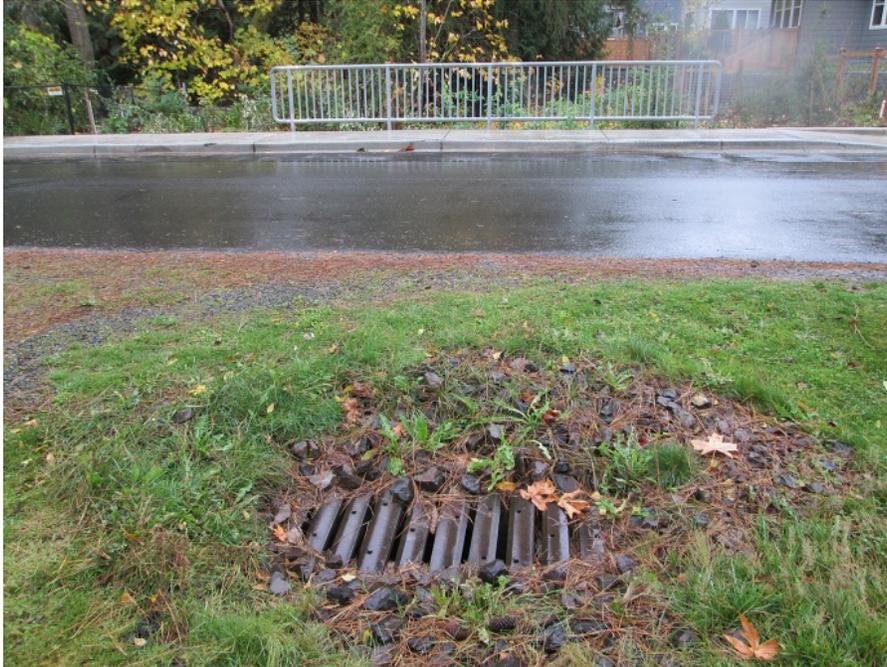
Photo 5 – Looking south – Catch basin with a large custom grate, flows are conveyed south across the roadway to outfall into a stream.
